## OBSERVATIONS OF SMOULDERING FIRE IN A LARGE TIMBER COMPARTMENT

Harry Mitchell<sup>1</sup>, Rikesh Amin<sup>1</sup>, Panagiotis Kotsovinos<sup>2</sup>, Mohammad Heidari<sup>3</sup>, Daniel Thomson<sup>2</sup>, David Barber<sup>4</sup>, and Guillermo Rein<sup>1</sup>

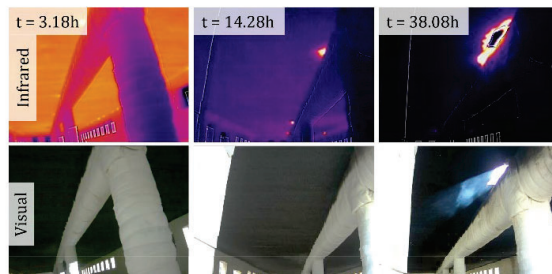
**Figure 2:** Initiation and spread of an observed hotspot in CodeRed #01, underneath the concrete beam above the crib ignition line. At 3.18h after flames, the hotspot is only visible in infrared, and not visual observation. The hotspot spreads in-depth until a hole is formed through the ceiling, at which point the smouldering is visible due to the hole and smoke emitted.

In CodeRed #01, over the 38 h after flames, a hotspot developed and spread at the ignition end of the compartment (figures 2 and 5), at the midpoint of the CLT

surface near the mineral wool insulated concrete mid-span beam. Infrared imaging was applied to identify the location of the hotspot which immediately after the end of flames were not otherwise identifiable from direct observation. Figures 2 and 5 show that smouldering occurred in the CLT in a small, localised region, which grew in area over the span of 38 h after the end of flames. At 38 h after flames, a 23 min period of rainfall occurred, causing the smouldering to extinguish. Although suppression is an important tool in fire response, without thermal tools such as thermocouples or IR cameras these hotspots can be hard to identify before they begin to alter the structural capacity of the mass timber element.

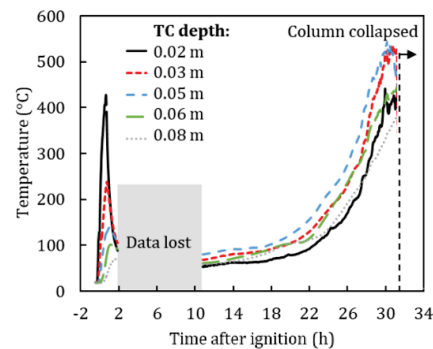
**Figure 3:** Column base temperature in CodeRed #02 after ignition. Flames lasted for 27 min before temperatures decayed to ambient levels. In the 32 hours following this, the base column temperatures increased steadily, indicating smouldering.

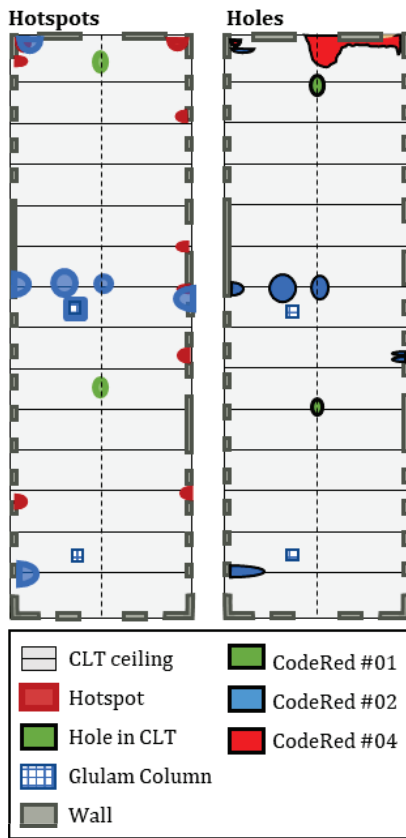
Smouldering hotspots in the ceiling initiated exclusively along the edges of each slab, including connection lines between two CLT slabs, connections between the wall and CLT slabs, and the interface between CLT slabs and the insulated concrete column along the compartment length. A summary of the smouldering observed over the three experiments is outlined in table 1.

**Figure 4:** Sketch of smouldering hotspots in the ceiling and columns from the end of flaming to the end of smouldering (> 48 h) in each experiment. Straight black lines represent edges of timber slabs.

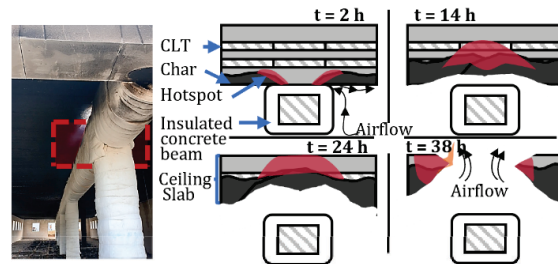
**Figure 5:** Sketch of smouldering hotspot during CodeRed #02 progressing through the ceiling thickness, and forming a hole in the ceiling.

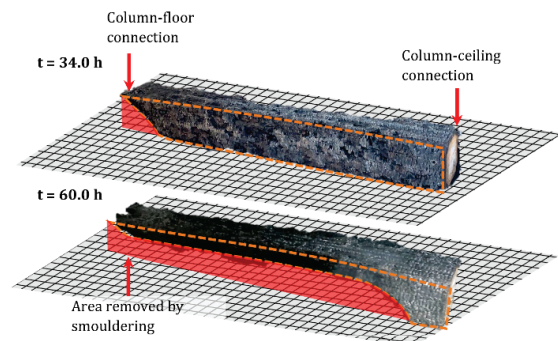
embedded both inside the timber element and along the glue line began to increase above ambient conditions from around 12 h following the end of flames, indicating the spread of smouldering from the base of the column in-depth and upwards along the column length. Smouldering at the base of the column was also observed with IR imaging. The column base smouldered for 31.82 h through the cross-section of the column base until the top of the column was observed to shift from the ceiling connection point. At 32.02 h, as shown in Fig. 6, the column collapsed fully onto the floor. This was attributed to degradation of the column base cross-section due to continued smouldering.

Embedded thermocouples at the base of the column are depicted in Fig. 7, showing the column base reaching up to  $500^\circ\text{C}$  at 28 h after the end of flames, above the temperature at which flaming could reoccur. After the column collapse, the side of the column facing the floor continued smouldering, resulting in near-full decay of the column cross-section across the column length, as shown in figure 6.

**Figure 6:** Smouldering under collapsed Glulam column from CodeRed #02 after collapsing to the concrete floor.

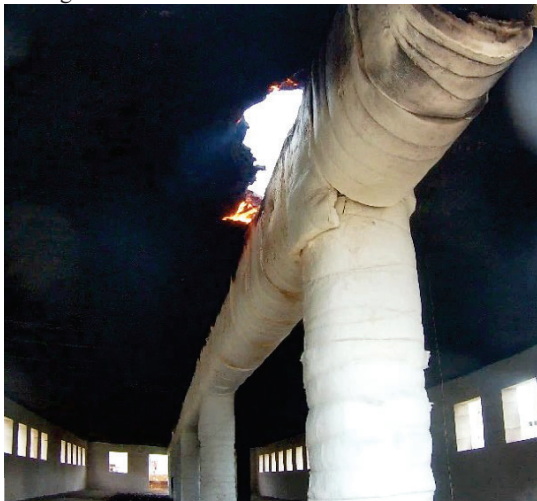
Given suitable conditions, smouldering can transition from flameless combustion to flaming combustion. Smouldering to flaming transition is primarily driven by a change in heat flux incident on the smouldering surface, and oxygen supply to the smouldering reaction [20]. Transition to flaming can present a hazard to timber structures following the end of flaming by producing new fires hours after the original fire had ended. This can be particularly hazardous in the case of smouldering that forms penetrations to adjacent compartments or other floors, such as in Fig. 7, as this can lead to unburnt compartments being exposed to a new ignition source. Smouldering spread and transition to flaming can be more likely to occur with the provision of insulation close to the smouldering surface, while still providing a small gap for air flow. In several smouldering hotspots, transition to flaming was observed following the formation of holes in the ceiling. This is due to an increase in air flow local to the hotspot, providing greater oxygen to the smouldering process, allowing a greater rate of char, leading to flaming.

*Figure 7: CLT ceiling smouldering hotspot 40 hours after flames, forming a hole in the CLT. Transition to flaming is also observed.*

Suppression and subsequent extinction of smouldering hotspots was also observed, both by short 20–40-minute periods of rainfall and direct intervention by firefighters using a firehose. Rainfall was only observed to be partially effective at extinguishing hotspots, whereas after significant intervention a firehose was successfully used to extinguish a smouldering hotspot.
