ENABLE THE USE OF MASS TIMBER PRODUCTS FOR NON-RESIDENTIAL BUILDINGS IN HIGH VELOCITY HURRICANE ZONES

KEYWORDS: Cross-Laminated Timber, High Velocity Hurricane Zones, Debris Impact Test, Cyclic Wind Pressure Loading Test

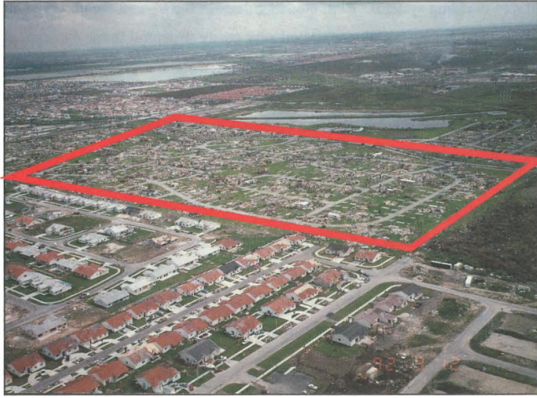
Figure 1.1: Building performance difference between manufactured homes (outlined in the center) and conventional residential buildings (lower left) (FIA, 1992).

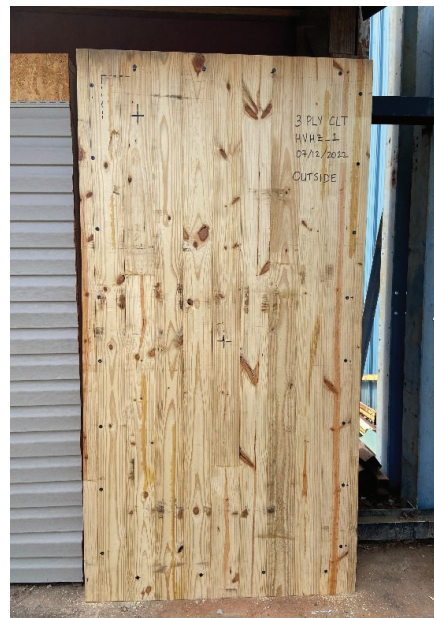
Figure 2.1: Test setup for large missile impact test

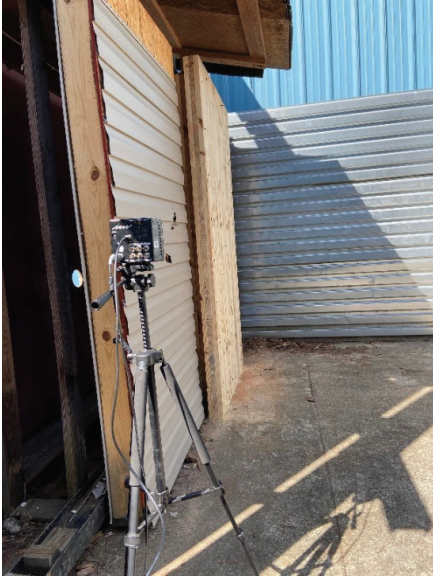
Figure 2.2.a: Missile speed calibration with a high-speed camera

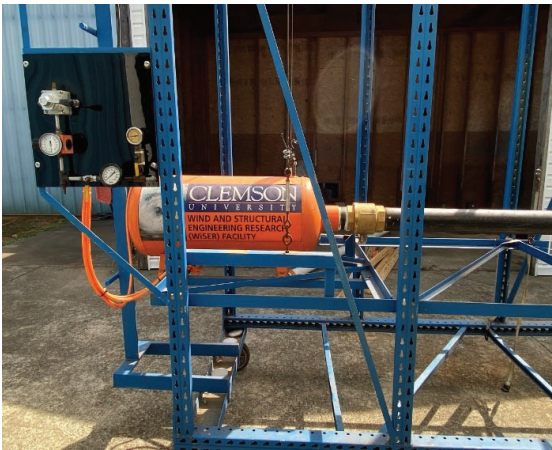
Figure 2.2.b: 33-gallon compressed air tank used to propel missiles

propelled using a 33-gallon compressed air tank, shown in Figure 2.2.b.

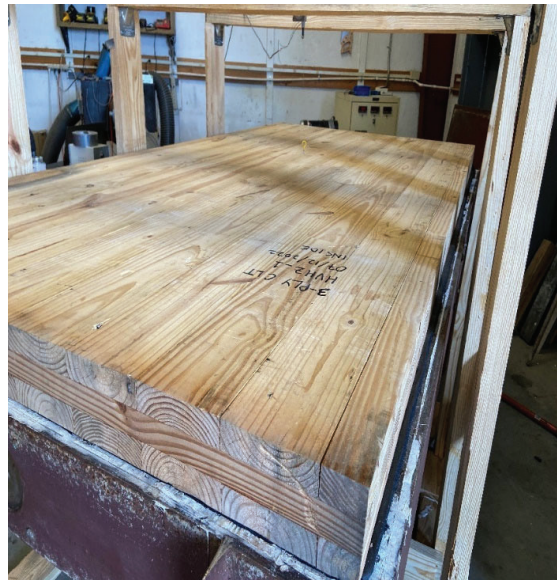
Figure 2.3: Test setup for cyclic pressure loading test

Following the debris impact test, the CLT specimens go through the cyclic wind pressure loading test in conformity with Section 1626 of FBC and TAS 203-94. The assumptions for wind loads are determined using the Directional Procedure in ASCE 7-22, shown in Table 2.2. Additionally, the loading schedule for the cyclic test is shown in Table 2.3. Figure 2.3 shows the test setup for the cyclic pressure loading test.

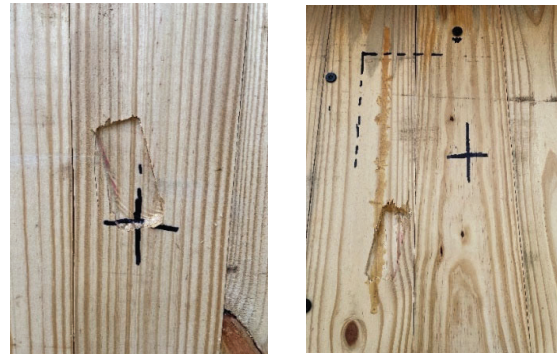
(a) Center

(b) Corner

Figure 2.4: Missile penetration depth of large missile test

A CLT panel specimen was tested for the large missile. It received two impacts at the center and corner 152.4 mm (6 in) away from supporting members, shown in Figure 2.4. Table 2.4 shows the summary result of missile indentation for the test while Figure 2.4 shows their corresponding pictures. There were indentations of 6.35 mm (0.25 in) and 12.7 mm (0.5 in) at the center and corner, respectively. This corresponds to 6% and 12% of the CLT panel thickness (105 mm or 4.125 in), respectively which are minimal damages to the panel.

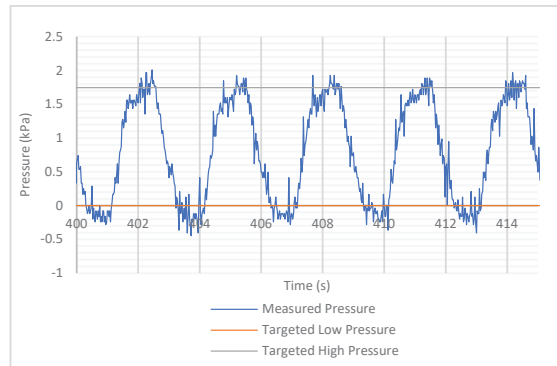
Figure 3.1.a: Measured pressure for 5 cycles of 0-1.77 kPa

The measured pressures in the chamber were consistent with the targets outlined in Table 2.3. Deviation of the pressures from the target value was limited to 11% for the testing shown. Such deviation was the result of the pressure cycles which approached 0 Pa as they had the potential to interrupt the seal. Efforts were made to minimize deviation through the testing protocol such as

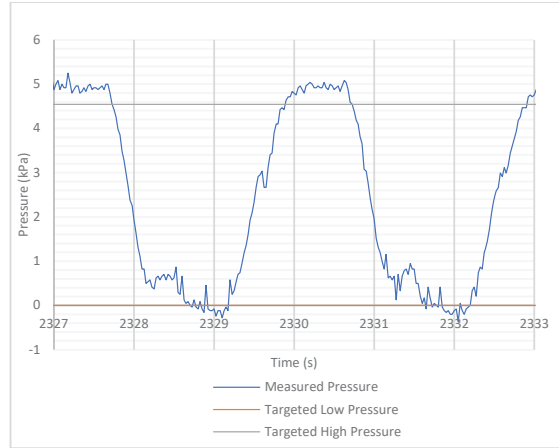
Figure 3.3.a: Measured pressure for 5 cycles of 0-4.55 kPa

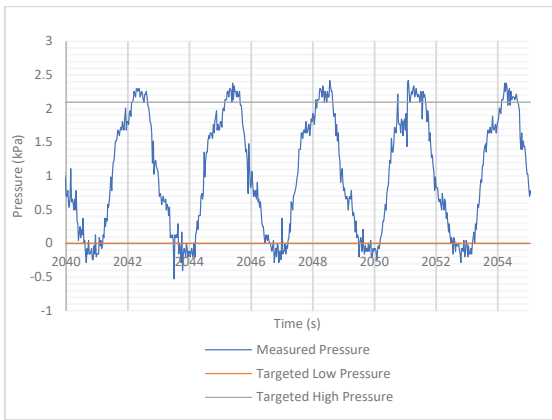
Figure 3.2.a: Measured pressure for 5 cycles of 0-2.11 kPa

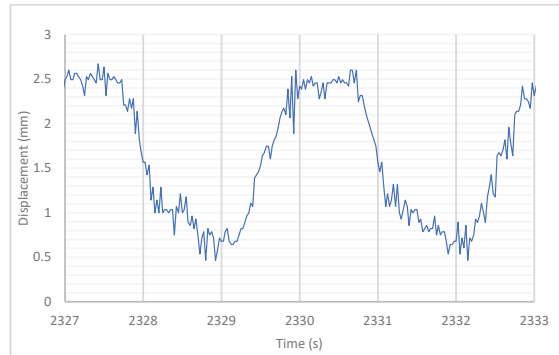
Figure 3.3.b: Measured displacement for 5 cycles of 0-4.55 kPa

A specimen was tested for cyclic wind pressure loading test with the loading schedule, shown in Table 2.3. The maximum deflection was measured to be 2.845 mm (0.112 in) throughout all three loading cycles with a permanent deformation of 0.686 mm (0.027 in). No crack or opening formed during or after the experimental test. Figures 3.1, 3.2, and 3.3 show the pressure loads and deflection for several cycles of the three loading cycles respectively (Table 2.3). The CLT specimen remains elastic during the cyclic test, as shown in Figure 3.4.

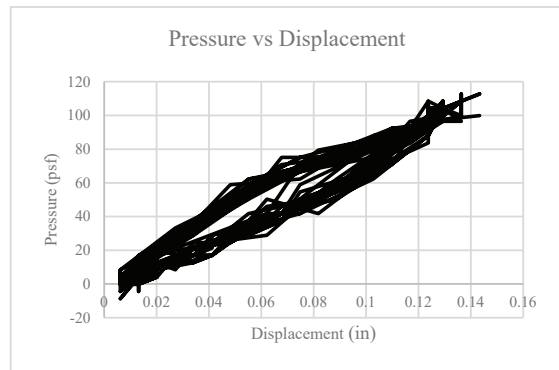
Figure 3.4: Result from the preliminary test
