WEAR RESISTANT PROTECTION OF WOODEN POLES IN ADVERSE ENVIRONMENTS

Thomas Lindblad¹, Knut Magnar Sandland², Andreas Treu²

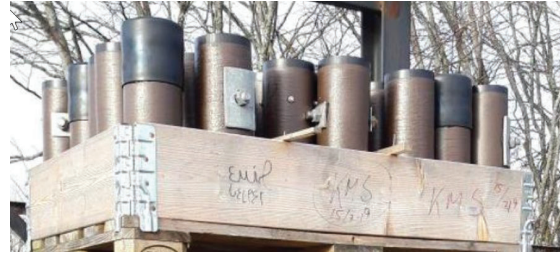
Figure 3: Exposure to outdoor climate.

Starting in May 2019, different connection solutions (see table 1 and example in figure 1) were analysed using water submersion test at the NIBIO laboratory for 1600 hours. The samples were stored between submersion cycles in the freezer and in room climate. Thereafter, the test pieces were exposed to outdoor climate for 700 days (figure 3). Measurements were done twice per year. The weight change during submersion and exposure were measured gravimetrically using a 0.1 g readability scale. (Mettler ToledoPG5002-S DeltaRange), except for test series 21-25 where a 0.5 g readability scale was used (KERN DE 6K0,5N).

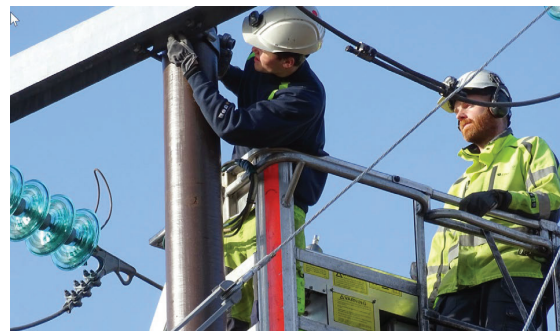
Figure 4: Fitters from Linde Energi using French bolts with mastic to prevent sliding and rotation of cross arm fitting.

A 40 kV overhead line with 108 WOPAS poles was installed early 2019 and finalised in May the same year (see figure 4). The fitters used WOPAS recommended fasteners, i.e. pin bolts with curved washer and mastic, French bolts with mastic and building board screws with gasket. The installation was surveyed in June 2022 by a third-party wooden pole expert, representatives from the grid owner and WOPAS. The time frame between installation and survey equals the time frame for the accounted laboratory tests in 2.1.

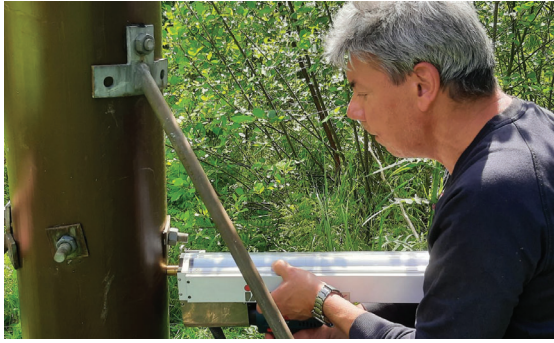
Figure 5 Drilling measurement using a resistograph, close to pin bolt with curved washer and mastic.

Of the 108 poles a selection of eight poles was installed in different environments, such as arable land, forest, swamp, rocky ground and gravel. Several methods were used for the survey, such as classical hammer sound surveying, non-destructive electronical moisture meter by Tramex and drilling resistance measurement by use of an IML Resi F400-SX. Drilling was either made just above the ground or close to penetrating fittings, as shown in figure 5. The drilling resistance measurement method enabled recording and print outs, as shown in figure 11. Neither the drilling resistance measurements, nor the survey in general, showed sign of deterioration of the poles.

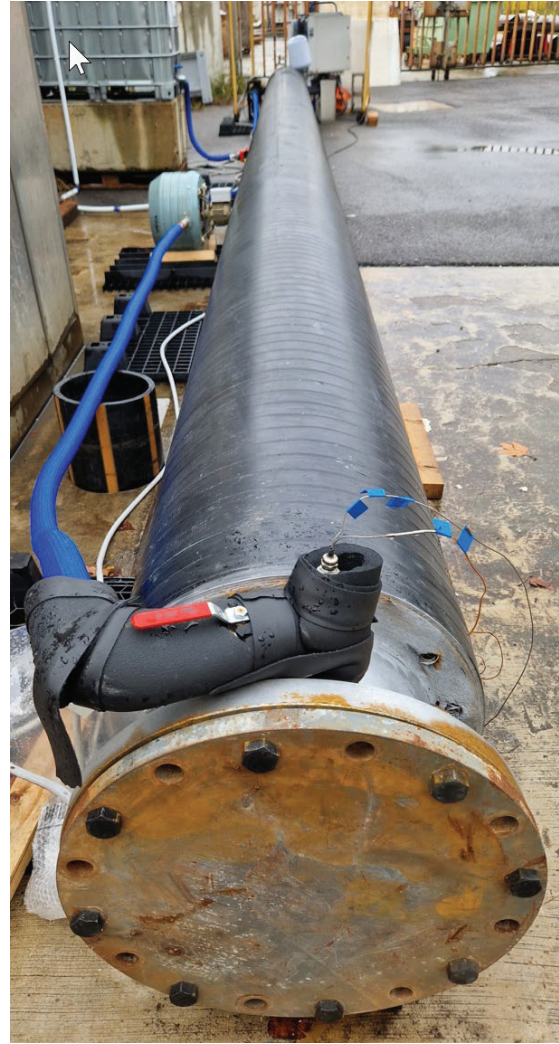
Figure 7: Steel tube containing a WOPAS pole for age testing.

Critical to the sealing function is the integrity of the PE over time. Test laboratory CESI of Milan, Italy, on behalf of power grid owner Enel Grids has conducted a test programme of 8 repeating steps during 2022. In addition to mechanical tests like impact protection⁵ (IK), bending fatigue and flame test, an ageing test was made to simulate outdoor daily cycle. The testing was made by placing a pole in an insulated steel tube filled with water, figure 7. The water temperature was controlled and varied between 20 and 80 °C (figure 6). The cycle consisted of 8 hours of heating and 16 hours of cooling. The thermal conditions of the cycle were described as consistent with climatic extremes to constitute an acceleration factor of the real stresses to which the pole is subject to in operation. The test was conducted for 1000 hours. The pole, sealed at the ends, is placed in a cylindrical chamber where water is circulated. The water was coloured to enable a subsequent verification of water ingress. At the end of 1000 hours the pole was extracted from the steel tube and inspected for cracks to the PE and welded end caps. The pole was then tested with a bending test to compare any deviation to other non-aged WOPAS poles. The PE layer was thereafter separated from the wood, and the moisture content of the wood was measured, as well as visual inspection tracing any coloured water penetration.

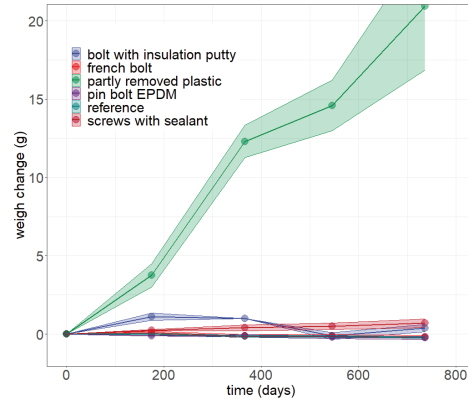
Figure 9 Weight change due to water uptake during more than two years of outside exposure. The colour-shaded areas show the standard deviation (N=5).

Minor weight changes during submersion and outside exposure were observed (figure 1 and figure 2). The water penetration through the used connections was therefore almost insignificant for all solutions except the use of bolts with insulation butty, which even showed mass loss during the exposure. This could have been caused by the different scale, which was used for these samples or by degradation of the washer. Reference poles with partly removed plastic coating showed higher water uptake during water submersion and outside exposure. The test proved the good performance of the sealants and underlines therefore the importance of the sealing material and the care during installation.

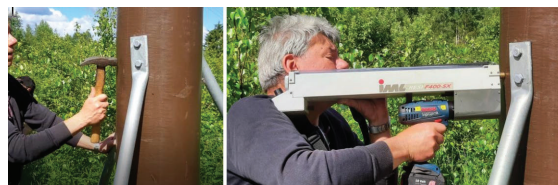
Figure 10: Anomalous sound from hammer was followed up using resistograph, in turn showing normal values.

The hammer control noted two anomalous sounds, one behind a mark caused by the installation of the poles using excavator grab john (hydraulic pin grab on the back side of the bucket) and another at a random place. Both locations were examined with moisture measurement and resistograph, but without anomalous values. One hypothesis discussed was that the pressure from excavator grab john caused some kind of local sound change, and natural cracks that occur in the wood may have caused abnormal sounds as well.

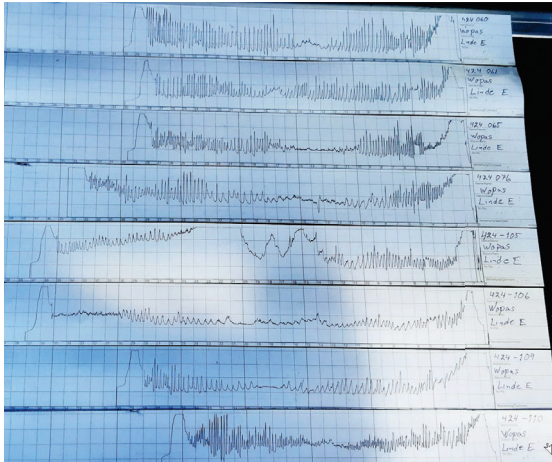
Figure 11: Paper print-outs of drilling measurement using a resistograph

The visual inspection showed no deviations. The construction was described as very well built by third party Vattenfall Eldistribution. The moisture measurements demonstrated no elevated values of wood moisture content. In addition, the resistograph showed no unusual values, which could indicate deterioration of wood components. See below the photograph of resistograph printouts, figure 11.

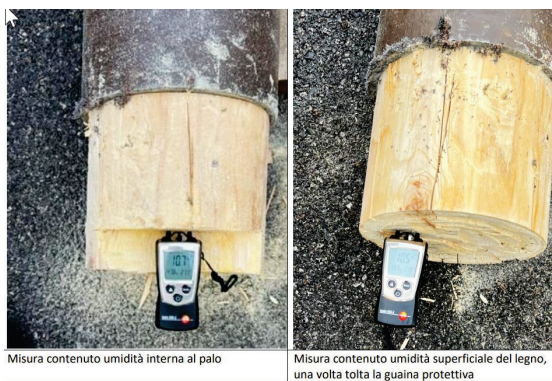
Figure 12: Moisture content observation after the aging test

After the aging test, the pole was tested for bending, impact (IK) and the PE was removed to measure the moisture level and for visual inspection of any coloured fluid. Even after the bending test, no damages were found on the PE, and no water ingress could be noted. The moisture level was observed at two positions, as shown in figure 12, and the moisture level was 10,5-10,7%. It has been pointed out by CESI and Enel Grids that the specification and aging method have been defined by them for their test, and cannot be extrapolated. Furthermore, it was described that the PE was well attached to the wood and is able to fill even the natural cracks. In this way the PE is not free to move, which was also verified during the torsion test. The PE-welded end caps were considered the weakest point before the test. However, it demonstrated to be adequately robust for the intended use as power pole, both in terms of aging and impact. In fact, the impact protection rating corresponded to IK10 according to norm IEC 62262, or 20 Joule (weight of 5 kg from a height of 400 mm).
