# PATINA AND ITS FORMATION ON A WOODEN CHURCH FLOOR – CASE PETÄJÄVESI OLD CHURCH AND VIKKI CHURCH IN HELSINKI

**Jonna Silvo<sup>1</sup>**

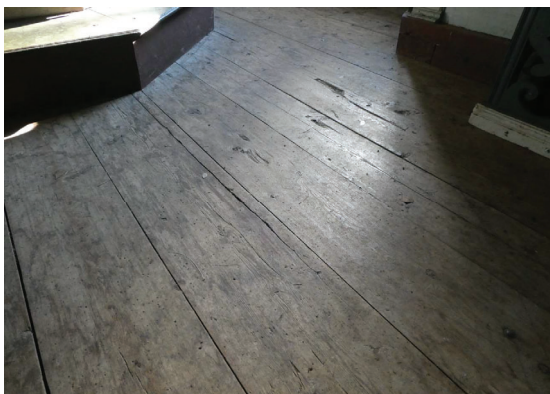
**Figure 1:** An old patinated wooden floor in Finland. Wearing is characteristic for wooden floors.

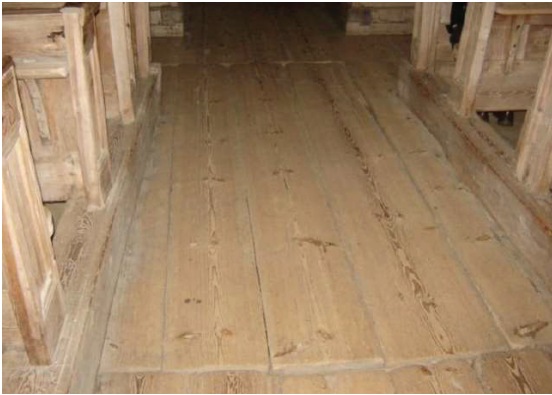
**Figure 3:** *The dimensions of wooden planks of Petäjävesi Old Church floor are large, which was the standard at that time when the sawing was not industrial as today. The surface of the floor has worn unevenly.*

Today the church floor is beautiful, and the surface of the wooden planks has worn very smooth. The floor is thought uneven. The knots and other harder places have not worn as much as the softer parts of the planks. The surface of the floor is untreated.

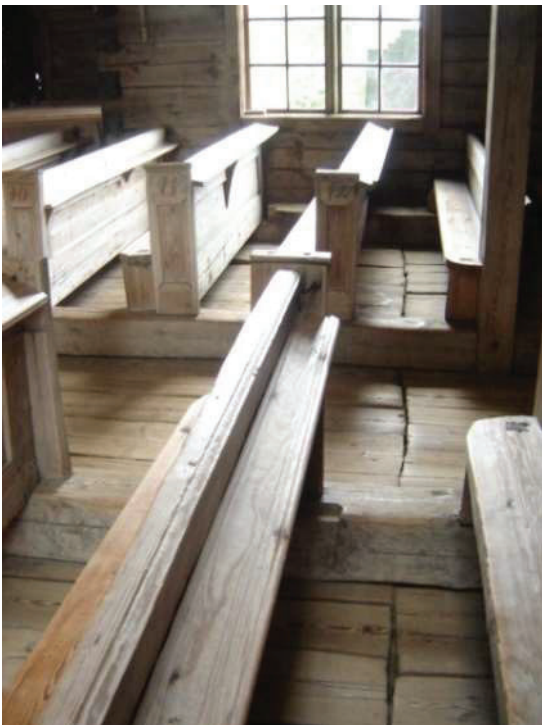
**Figure 4:** *The patinated interior of Petäjävesi Old Church somehow feels timeless.*

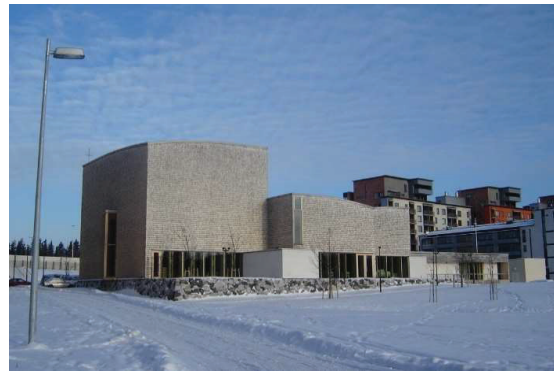
**Figure 5:** *Viikki Church in winter 2006. The exterior of Viikki church is clad in cleft aspen shingles and they have turn grey during time as originally planned.*

Viikki Church (Figure 5.), built in 2005 and designed by JKMM Architects, represents modern Finnish wood architecture [10]. The main parts of the church are wooden. In the church the bundle-like glulam pillars function as load-bearing vertical designs. The frame has been partly braced with reinforced concrete. The spruce panels and boards of the hall walls and all the floors are of radially sawn spruce, which minimizes the movement of the wood indoors. The flooring material is massive spruce boards and the base floor is stone structured. The furniture has been tailor-made to suit the church activities. The interior of the church hall is presented in Figure 6.

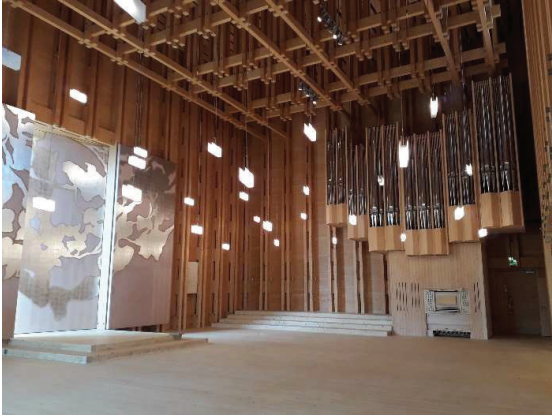
**Figure 6:** The large wooden floor of Viikki Church is built with the combination of under-floor heating together with a reinforced concrete foundation. When the floor is serviced annually, the chairs are moved out of the way.

The large wooden floor of the Viikki Church (Figure 3.) is made of feathered spruce floor boards (30 mm x 120 mm) sawn between the tangential and radial directions. The floor is treated with a mixture of lye and oil.

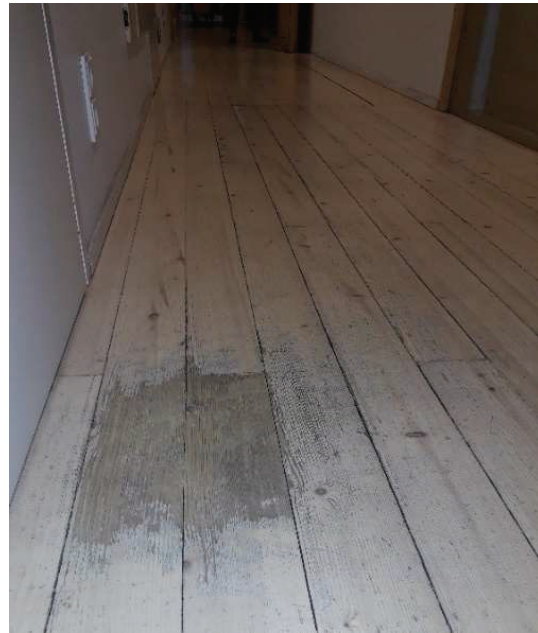
**Figure 7:** The wearing of the floor in front of a frequently used cabinet, has been intense compared to the surrounded floor.

The spruce floor in Viikki Church has worn during the past 15 years after completion of the floor (Figure 7). When designing the church, the original idea was that like in many old churches the floor would patinate beautifully over time. In Viikki Church, however, soon after the building was completed it was noticed that the wearing of the floor was very uneven. Some of the boards were also splitting. In discussions with the persons responsible of the maintenance in Viikki church in Finland it has occurred that these persons fear that the users of the church consider a worn floor as a soiled one and not aesthetically pleasant.

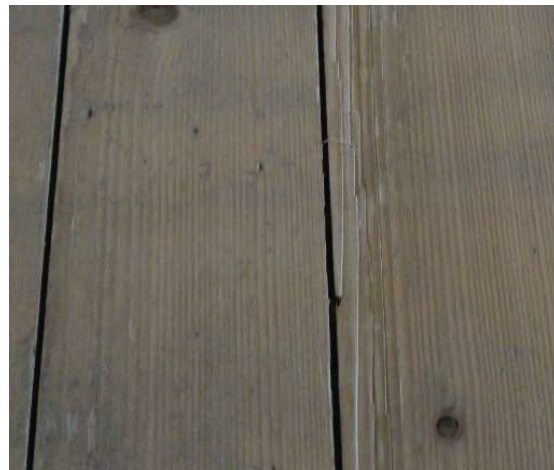
**Figure 8:** Splitting of the boards in has been a problem in Viikki Church.

For getting more information the users of the Viikki Church were interviewed around this theme [11]. In the comments from Viikki Church the sticks splitting of the floor came up. Some of the respondents connected the wearing of the floor to the splitting of the boards. If the splitting would not have occurred, the wearing would not have disturbed that much. The splitting of the boards (Figure 8.) were especially irritating parents of children that were visiting the church. Unlike the adults, children did walk with socks on the church floor and got sticks on their feet.

In retrospect can be said that splitting and sticking of the boards could probably have been prevented by being more precise about the quality of the floorboards, so that all the boards would have been exactly radially sawn. Even if the costs in this way would have been higher in the design and building phase, from a wood technical point of view, the better quality floor probably would have paid for itself during the decades if the floor does not have to be maintained as often.

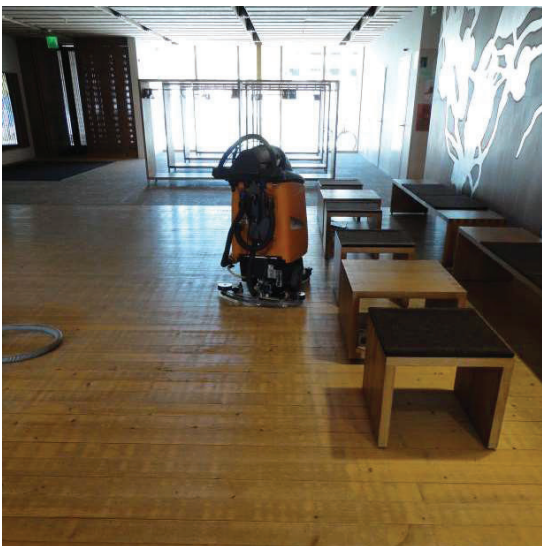
**Figure 9:** The wooden floor of Viikki Church is regularly machine washed but only some moisture is absorbed in the floor.

A random visitor in the church does of course not face the same problems with the floors that a permanent visitor, or people working in the churches every day do. It is true that it does not help that a floor looks beautiful if it complicates you of doing your work for example when you are cleaning (Figure 9.). It can be stated that wearing of the floors has been more a functional problem than an aesthetic one.

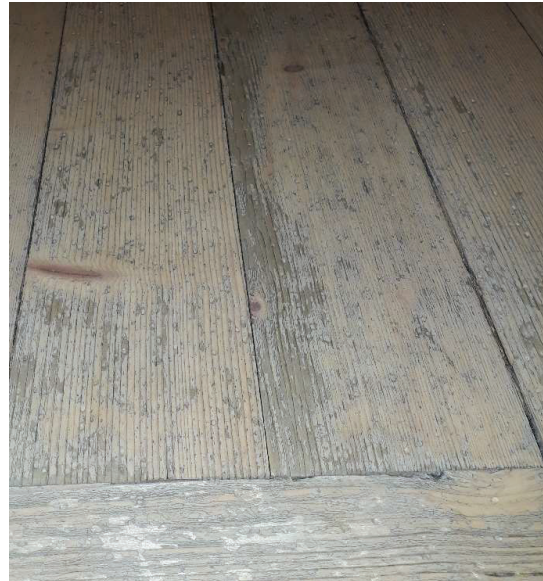
**Figure 10:** The floor before it had been sanded. The small round marks are caused by the spikes of the anti-slip pads people use on the shoes when it is slippery during winter time in Finland.

Besides the wearing of the wooden floors, the floors have of course also been soiled during the years and it is impossible to have them look like new ones with the existing cleaning methods. Still, it can be asked should a wooden floor look like a new one when time goes by. In figures 10. and 11. we can see the difference between a worn floor and a newly sanded floor.

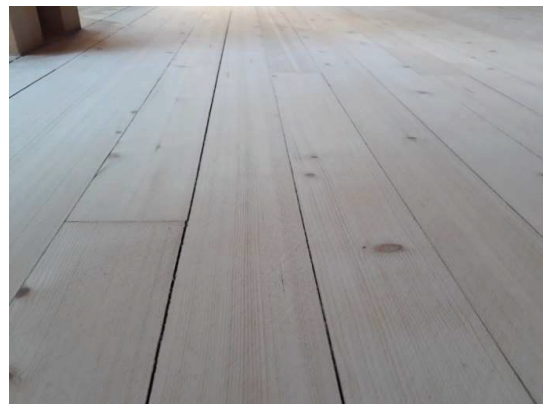
**Figure 11:** The floor after it had been sanded the first time after fifteen years. If the floor will be sanded regularly, it is impossible that the surface would start to patinate as the old wooden floor. On the other hand also the used dimensions are smaller than in the past.
