## STUDY ON ENVIRONMENT DECOMPOSITION AND STRENGTH OF CLT WHEN TEMPORARILY USED ON CIVIL ENGINEERING

**ABSTRACT:** This study examines the civil engineering use of CLTs; if the civil engineering use of CLTs is promoted, the supply of domestically produced CLTs will increase and stabilize, and the price of CLTs will decrease. The purpose of this study is to verify the conditions of use and decomposition in a civil engineering environment. As initial tests, visual observation, 3-point bending tests, and compression tests were conducted to verify the rate of strength degradation and degradation conditions for each elapsed month. As a result, since there was a large strength fluctuation at the same moisture content in terms of the embedded yield strength, an additional verification using small specimens was conducted. The results suggest that the strength reduction in the buried specimens was due to the absorption of water during the burial period, as well as minor but significant biodeterioration.

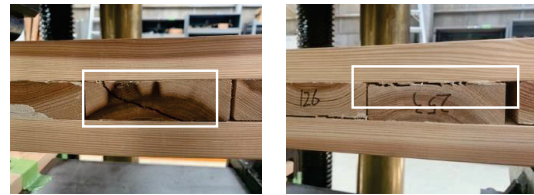
Figure 4: Fracture Properties

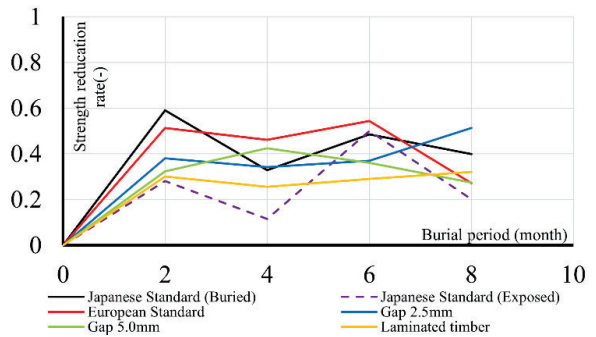
Figure 5: Yield Bending Strength Reduction Rate

Figure 5 shows the rate of decrease in yield bending strength. All the specimens showed a large decrease in the second month, but the rate of decrease fluctuated afterwards repeatedly since then. Although there was some variation, the rate of decrease in strength of the glued laminated timber was smaller than that of the CLT. Within the scope of this test, there was no clear difference in the effect of securing gaps as a route of entry for rotting fungi and termites, or of the presence or absence of gluing of the width-bonding. It was also confirmed that the strength loss of the specimens exposed outdoors was smaller than that of the specimens buried in the soil.

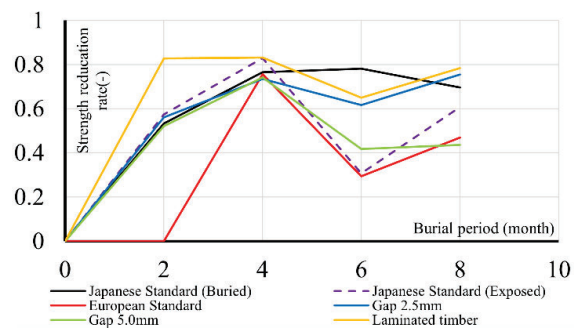
Figure 7: Embedded Yield Strength Reduction rate

The test results are shown in Tables 4. Unlike the bending strength properties, there was no significant difference between the glued laminated timber and CLT specimens in terms of the embedded stiffness. The percentage of decrease in yield strength under shear (Figure 7) shows that the percentage of decrease in yield strength under shear was larger than that of yield bending strength for all the specimens. Therefore, in outdoor use of CLTs, it is necessary to consider the decrease in the embedded strength during the service period.

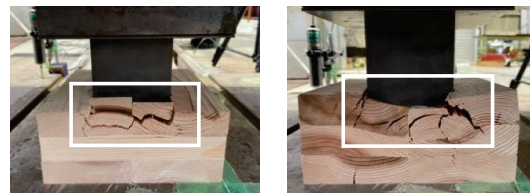
Figure 8: Fracture Properties

In terms of the embedded yield strength, the rate of strength reduction tends to be greater for glued laminated timber than for CLT. The parallel fiber lamination of the glued-laminated timber may have weakened its resistance to compression. A comparison of fracture properties (Figure 8) shows that timber cracking was concentrated in the first layer of CLT, whereas cracking also occurred in the second and third layers of glued-laminated timber. In addition, in the glued-laminated timber, the timber in the upper layer was embedded into the timber in the lower layer, which is thought to be one of the reasons for the reduction in bearing capacity that is assumed to occur when the timbers are stacked in the parallel direction to the fibers.

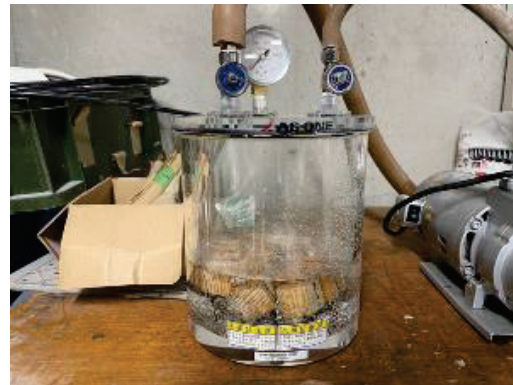
Figure 10: Vacuum Suction

The specimens with vacuum-absorbed water also showed some variation. One of the reasons for this may be that CLTs are subjected to a greater load than solid timber because the expansion of CLTs is inhibited by the adhesive, which is a factor in the expansion of timber as a result of water absorption. The adhesive used was a water-based polymer isocyanate adhesive, but the effect of the adhesive needs to be further investigated.
