EXPERIMENTAL STUDY OF A TYPICAL EXTERNAL WALL-FLOOR-WALL CONNECTION IN A CLT PLATFORM TYPE CONSTRUCTION

ABSTRACT: This paper presents experimental studies of a typical external wall-to-floor-to-wall connection in a cross laminated timber (CLT) platform type construction in context of disproportionate collapse resistance. The studied connection mimics the finite element models developed by other authors in the international timber robustness research community. The assembled specimens were tested with aim of staying in the linear elastic range and understand how the rate of loading affects CLT and its connections. This study presents data of the observed behaviour of CLT, steel brackets and screws subjected to different rates of loading. Obtained results and observations will inform future testing programmes and experimental analyses whereby aim is to test the specimens beyond the linear elastic range and to failure.

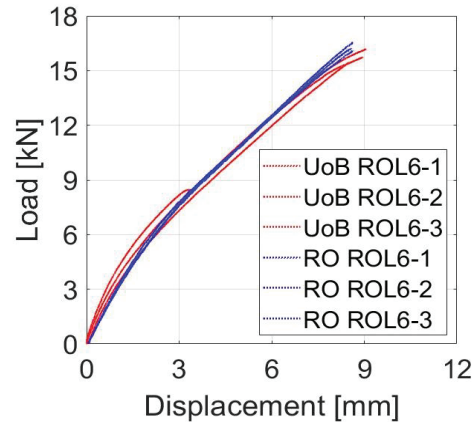
Figure 6: Load – displacement for ROL 6 mm/min

The results and observations of experiments are presented with series of graphs and tables below. Results obtained at C4 are not representative since they appear to be beyond the linear elastic state yet are still presented. The studied WFW connection is identified as a semi-rigid connection.

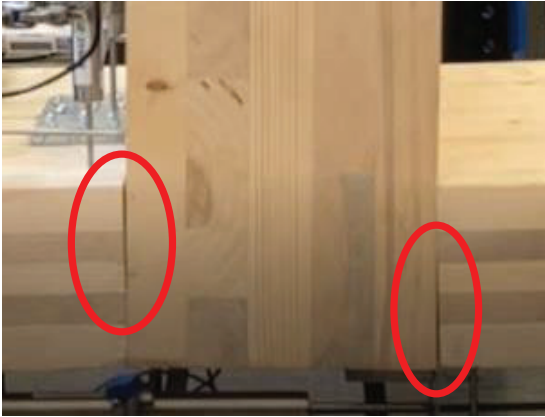
The bottom wall drops under the subjected loads. This results in opening between the floor element and the bottom wall as displayed in Figure 11. Consequently at C4 the strength perpendicular to the grain in the outer lamellas of the floor element was overreached and local crushing of the CLT occurred, because displacement was greater than in C1-C3. Figure 12 and Figure 13 display local crushing to the CLT.

Figure 11: Reversible opening for all ROLs when B2

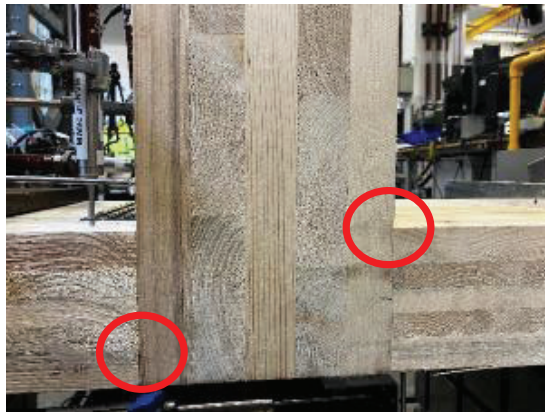
Figure 12: Localised crushing to floor at both walls (specimen with generic bracket B1 UoB at C4)

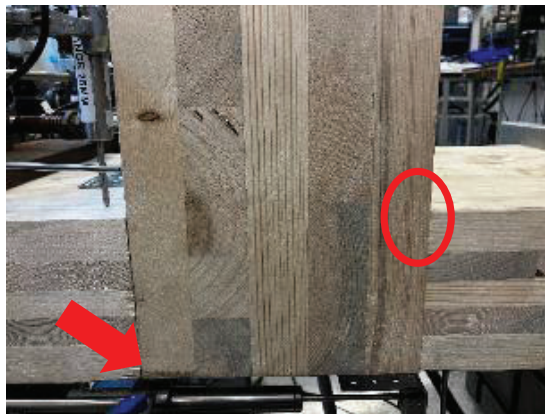
Figure 13: Localised crushing to floor at the bottom wall (specimen with Rothoblaas bracket B2 RO at C4)
