FIRE-PROTECTED TIMBER ELEMENTS OF CONSTRUCTION – RESPONSE DURING FIRE DECAY AND COOLING PHASE

Paul England¹, Boris Iskra²

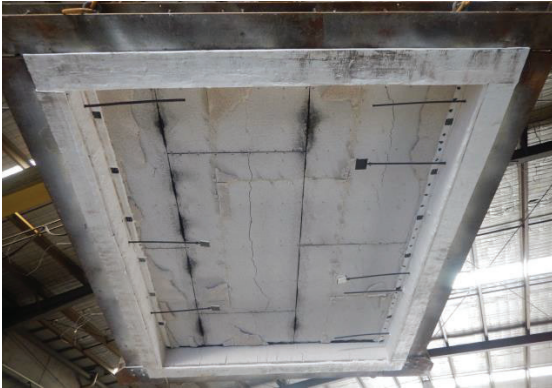
Figure 2: Exposed face of specimen at the end of the monitoring period.

After 120 minutes, the heating was terminated and the specimen was raised 600 mm above the furnace allowing free access to the laboratory atmosphere while being exposed to heat from the furnace floor and walls to simulate the decay and cooling phases under natural convection. The floor-ceiling specimen was then monitored for a further 17 hours without intervention – refer Figure 2.

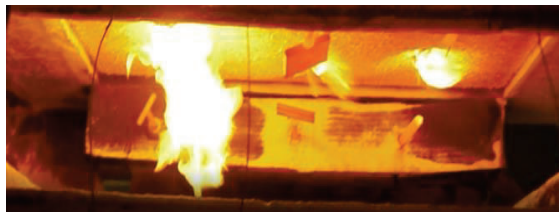
Figure 6: Flaming from joint between plasterboard 30 seconds after the end of the heating period.

At the end of the heating period the interface temperatures between the plasterboard and CLT were approximately 500°C and as the specimen was raised above the furnace to allow natural airflow across the surface of the specimen, flaming at the joint between the plasterboard sheets was observed as shown in Figure 6.

The flaming gradually reduced and ceased after approximately 11 minutes.

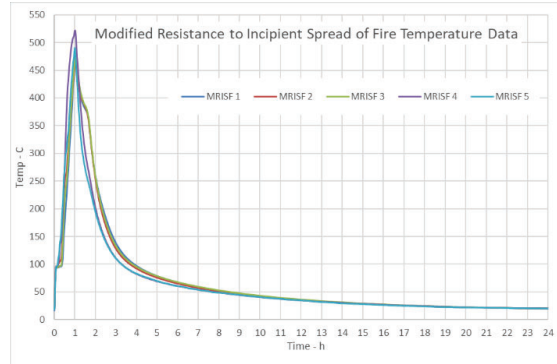
Figure 7: Thermocouple temperatures at the interface between plasterboard and CLT

Data monitoring continued for 23 hours and during this period, the CLT panel temperatures had effectively reduced to ambient temperatures with no evidence of continuing flaming or smouldering combustion – refer Figure 7 for interface temperatures between the plasterboard and CLT, and Figure 8 for the temperatures of the CLT panel at varying depths.

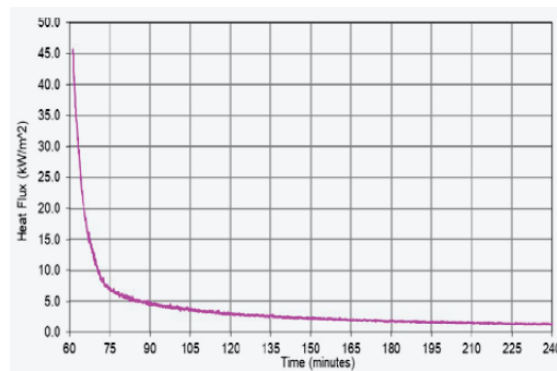
Figure 9: Heat flux from furnace and specimen for 180 min after heating

The incident heat flux to which the underside of the specimen was exposed is shown for the 180 minutes of the monitoring period in Figure 9. Approximately 11 min after completion of heating, the measured heat flux had reduced to approximately 10 kW/m²; at 42 min after completion of heating, it had reduced to approximately 4 kW/m² and 108 min after completion of heating, it had reduced to approximately 2 kW/m².

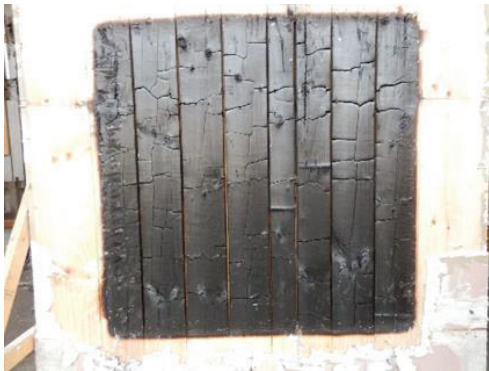
Figure 10: Underside of CLT panel with plasterboard removed after 23-hour monitoring period.

Figure 10 shows the CLT panel with the plasterboard removed clearly highlighting the surface charring to the lower lamella layer. No significant delamination had occurred, but the individual lamella had shrunk in dimension opening the edge joints between the lamella which were not bonded, i.e., no adhesive applied, during the CLT manufacturing process.

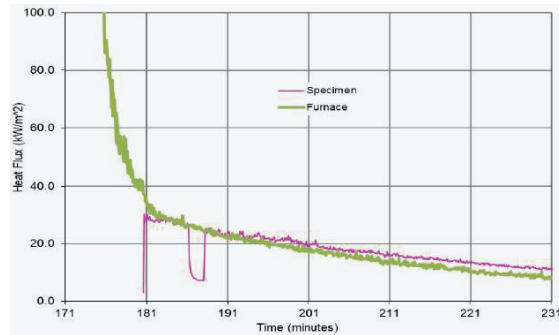
Figure 11: Heat flux from the furnace and specimen for 60 minutes after heating

Heat flux measurements from Test 2 during the decay period are presented in Figure 11. It is noteworthy that, despite evidence of some ongoing combustion, the decay of measured heat flux from the specimen (thin line) reduced to approximately 11 kW/m² after 60 min and the measured heat flux received by the specimen from the furnace walls and floor (thicker line) is comparable.

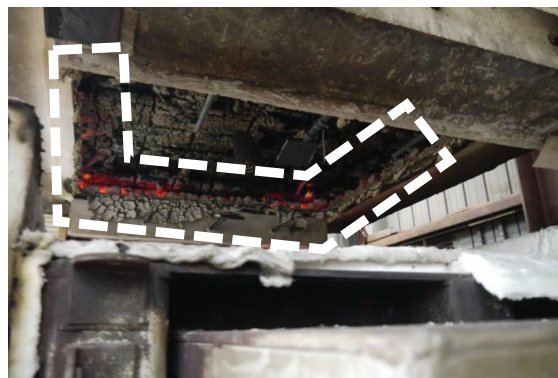
Figure 12: Fire side after the 59-minute monitoring period showing continued edge combustion.

Combustion of the specimen was ongoing at the joint positions and the exposed perimeter of the specimen at the end of the 60-minute monitoring period. Significant delamination occurred such that 90 mm or more of the specimen face had been lost over the heated area, creating a detail at the perimeter where a horizontal face meets a vertical face of timber, facilitating radiative feedback as shown in Figure 12.

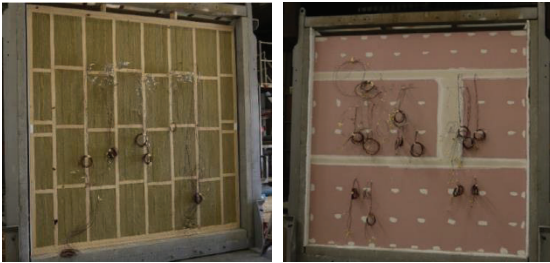
Figure 13: Internal structure and non-fire side of the high-performance timber-frame wall system

avoiding heat transfer through the cavity. The temperature data from the test indicated this was effectively achieved. Figure 13 shows the internal structure of the timber-frame wall system comprising vertical timber studs, horizontal timber noggings and fitted stone wool insulation.

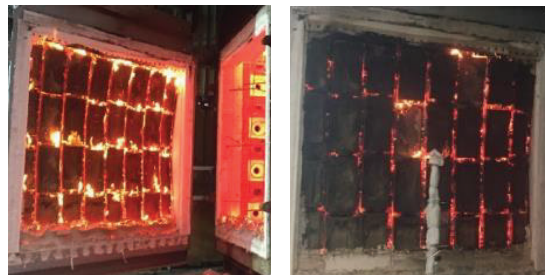
(i) Approx. 4 mins post-test (ii) Approx. 26 mins post-test

Figure 15: Exposed face of partition during monitoring period

At the end of the heating period the specimen was removed from the furnace. To enable observation and the fitting of a heat flux meter to measure radiant heat released from the specimen, the specimen was rotated at an angle to the furnace as shown in Figure 15.

Visual observations confirmed continuing combustion and char oxidation with a slight reduction in intensity further away from the furnace, which can be explained by the lower incident radiant heat from the adjacent furnace. Temperatures measured within the char were generally in the range of 500°C to 600°C throughout this period, indicating continued combustion within the char.

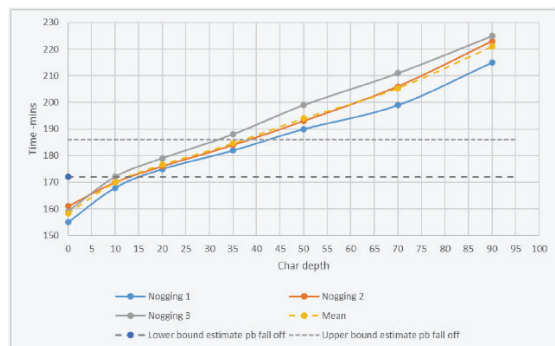
Figure 16: Char depth versus time along noggling centreline

Due to the test being of a loadbearing timber-frame, temperature data was obtained from three internal horizontal noggings containing thermocouples and is plotted against time in Figure 16.

Char rates obtained during the test were substantially higher than those recommended in EN 1995-1-2:2004 Eurocode 5[10] and AS/NZS 1720.4:2019[11]. For example, the notional char rate in accordance with AS/NZS 1720.4, assuming a nominal density of 550 kg/m³, would be 0.66 mm/min and for protected systems is increased by a factor of 1.1 yielding an increased char rate of approximately 0.73 mm/min. Whereas the average calculated char rate from commencement of charring (at approx. 158 minutes) to a char depth of 90 mm (at approx. 221 minutes) was 1.43 mm/min.
