## EXPERIMENTAL TESTING OF HIGH-CAPACITY SINGLE AND COUPLED CLT SHEAR WALL SYSTEMS

**ABSTRACT:** This paper presents an experimental study on three types of balloon-framed cross-laminated timber (CLT) shear wall configurations: (a) a single wall, (b) a coupled wall with a half-lap joint between wall piers, and (c) a coupled wall with steel link beams between wall piers. Three-storey, 2/3-scale CLT wall specimens were cyclically tested to failure and the results are presented to compare the performance between wall types. All specimens used 5-ply, 205mm-thick CLT wall panels with the same base connections of mixed-angle screw hold-downs and notched shear keys. The beam-coupled wall achieved a peak strength of 592kN and demonstrated the best performance among the wall configurations with the highest strength, stiffness, energy dissipation, and least amount of degradation under repeated load cycles. All the wall specimen exhibited ductile failure modes and demonstrated their feasibility to be designed for lateral load resisting systems in buildings.

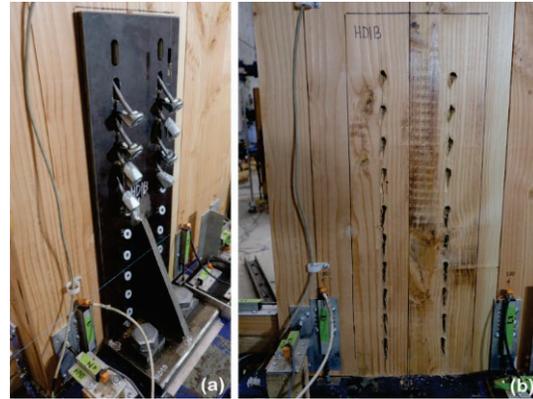
The mixed angle screwed hold-downs in each specimen experienced screw bending and withdrawal, in addition to local embedment crushing around the fasteners, as shown in Figure 5, due to the high uplift force demand. No screws in the hold-downs experienced fracture during the experiments, even though the maximum hold-down uplift displacement exceeded 100mm during the experiments.

Figure 5: Typical damage observed in mixed-angle screw hold-down connections: (a) screw withdrawal and (b) local wood crushing.

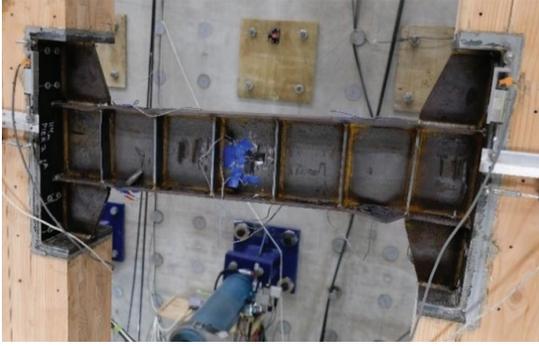
The BC wall experienced severe damage to the steel link beams, as shown in Figure 7. The webs yielded over the full length of the beams. In addition, the flanges adjacent to the end plate stiffeners yielded and eventually buckled inelastically. No damage was observed in the capacity-designed screwed end plate connections; therefore, the capacity design was successful.

**Figure 7:** Typical damage to steel link beams in beam-coupled wall specimen.
