YIELD MECHANISM OF PERFORATED PLATE CONNECTIONS FOR MASS TIMBER SYSTEMS

KEYWORDS: Braced Timber Frame, Ductile Connections, Structural Fuse, Perforated Steel Plate, Seismic Force Resisting System

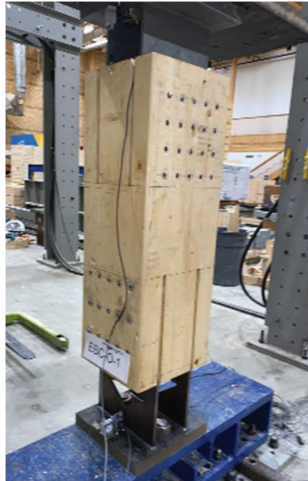
Figure 3: Sample specimen: (a) photo, (b) schematic, instrumentation included

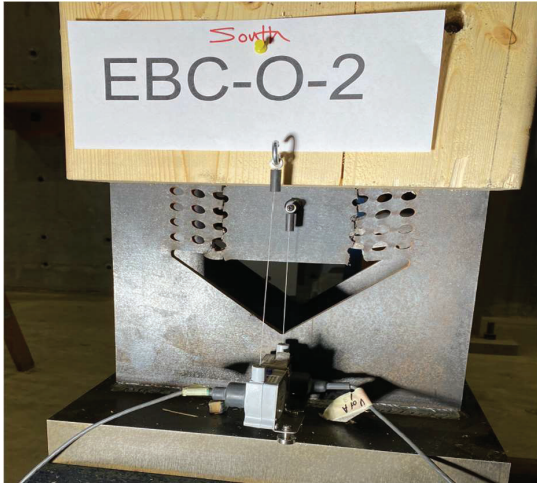
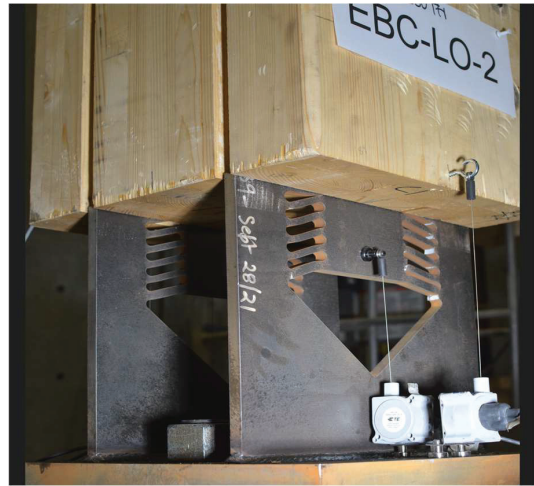
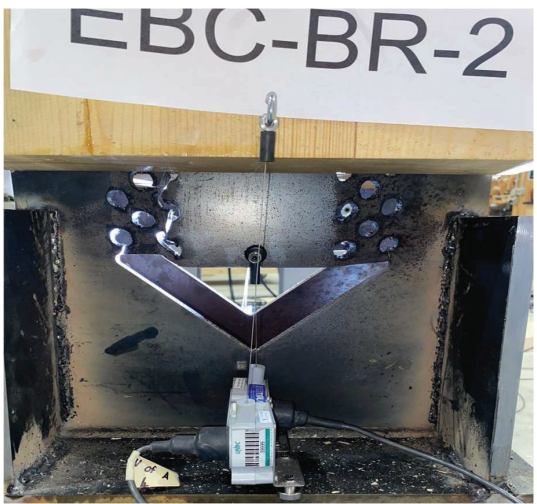
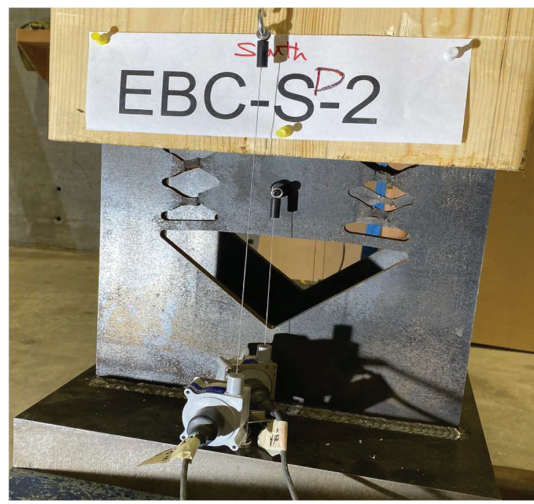
Figure 4: Failure modes and deformed shapes

The deformed shape and its corresponding load-deformation hysteresis curves for selected specimens are shown in Figures 4 and 5, respectively. Detailed analysis of the test results is currently in progress at the time of writing this paper. Some preliminary findings and test observations are presented below.

sudden rupture of inner link elements and propagates vertically to other elements in the row. Almost the same failure mode was observed in both replicates; the failure mode of EBC-O-2 is shown in Figure 5 (a). The other rows, while uniformly yielded, did not experience any rupture. Both specimens achieved similar ultimate displacements but different peak loads. The hysteresis curve of EBC-O-2 is shown in Figure 6 (a). As can be seen, the curve is wide, with substantial energy dissipation capability.

Due to a mistake in load application, EBC-S-1 was subjected to a monotonic load and buckled. EBC-S-2 was loaded cyclically, as anticipated; but similarly failed due to the global buckling of the knife plates, as shown in Figure 5 (b). The weak line was found where the perforation ends, and the triangular cut-out is maximized. While global buckling of the plates could be used as a source of energy dissipation, the difference in tensile and compressive responses, as noted in Figure 6 (b), might make it difficult to predict the onset of yielding. The pinching behaviour due to the buckling of the plate in compression is evident. Pattern EBC-S was initially aimed at achieving axial yielding in the perforation zones. The observed buckling behaviour necessitated modifying the perforation patterns to achieve the target failure mode. This led to the buckling restrained specimens of EBC-BR, as discussed below, in 3.3.

EBC-BR contains a larger perforation diameter compared to EBC-S. In addition, four stiff plates were welded to the outer sides of the knife plates. The failure mode of EBC-BR-2 is shown in Figure 5 (c). As can be seen, these two major changes caused the shift in failure mode from global plate buckling to axial yielding of link elements, as intended. The link on the inner rows is mainly ruptured due to excessive yielding, while there were no ruptures observed in other rows, although significant yielding was observed. Figure 6 (c) depicts that this fuse pattern possesses ample wide hysteresis curves, with improved strength and ultimate displacement, compared with EBC-S.

EBC-OS-1, similar to EBC-S-1 and EBC-S-2, globally buckled at the weak line of the minimum cross section. Increasing the size of perforations in EBC-OS-2 shifted the failure mode from global buckling to rupture in the perforation zones, as seen in Figure 5 (d). The intended axial yielding mechanism is achieved in the EBC-OS-2. Also, the pinching observed due to buckling in the hysteresis loops of the EBC-OS-1 faded away in the EBC-OS-2 responses, as shown in Figure 6 (d). The larger perforations also allow an increase in ultimate displacement achieved by the specimen.

The target failure mode for this pattern was flexural yielding, achieved by forming two plastic hinges at the ends of link elements. The two specimens behaved almost the same. Figure 5 (e) shows the failure mode of EBC-LO-2); the outer plastic hinges experienced rupture first in the majority of perforation zones, and then the failure propagated to the inner plastic hinges of the link elements. The hysteresis loops of the two specimens were almost the same; see Figure 6 (e) corresponding to EBC-LO-2, for instance. The results show reasonable ductility for the fuses, with large open hysteretic loops reflecting the ability of the fuse to dissipate energy. Significant ultimate displacements were observed with this pattern compared with other patterns, suggesting that the flexural mechanism, achieved with the long oval-shaped perforations, could be the desired pattern to improve the fuse behaviour under cyclic loading.

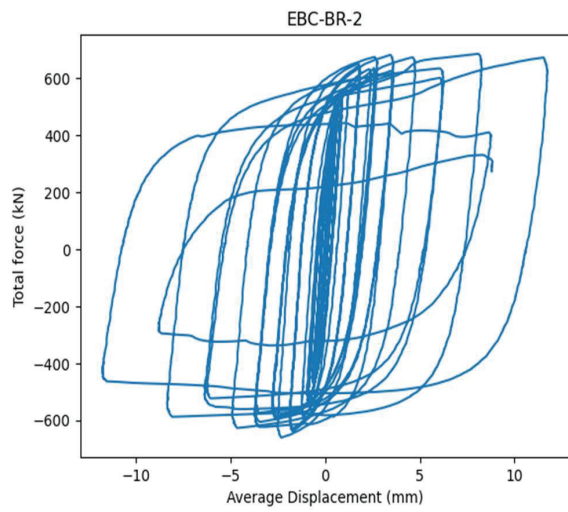
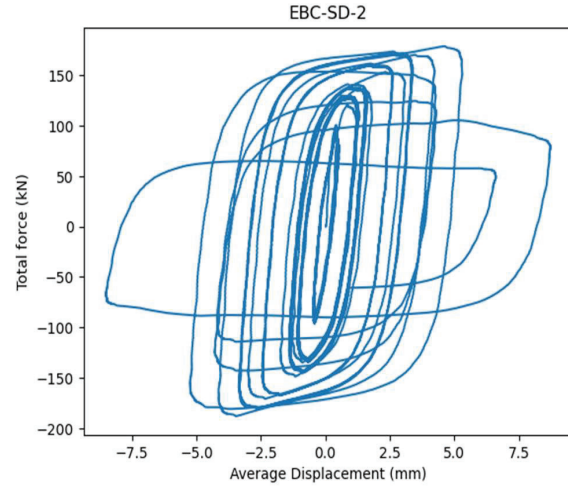
Figure 5: Hysteresis curves

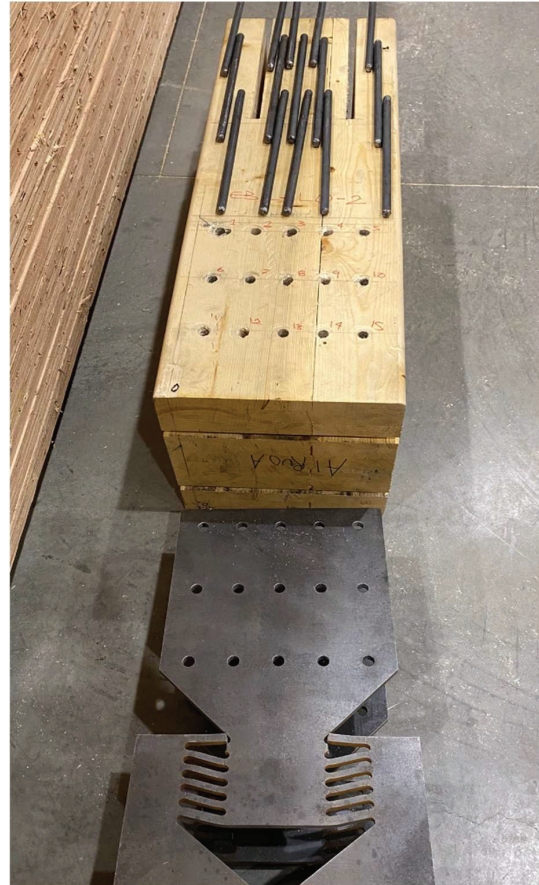
Figure 6: Resiliency in terms of replaceability

As illustrated in Figure 7, all damage was concentrated in the perforation zones. The capacity-protected steel dowel connections were undamaged and could be disassembled. The fuse end connection can be easily removed after the cyclic tests, representing the resiliency of the fuse with no damage to the timber component. To reliably design capacity-protected dowel-type connections, research to quantify the over-strength factor is ongoing.
