EXPERIMENTAL RESEARCH ON THE SEISMIC PERFORMANCE OF WATTLE AND DAUB INFILLED CHUAN-DOU TYPE TIMBER FRAMES

ABSTRACT: In the southwest of China, the Chuan-Dou type timber structure is widely seen in traditional dwellings, temples and halls, among which the wattle and daub (W&D) infilled wall is a relatively common embedded wall. Based on a large-scale field investigation of 30 traditional wooden structures in Chongqing, this paper had conducted experimental research on the quasi-static loading test of one bare Chuan-Dou frame and two W&D infilled Chuan-Dou frames with different wall thickness. The damage characteristic, bearing capacity, stiffness, ductility and energy dissipation of each specimen were analyzed. The results had shown that, compared with bare frame, the W&D infilled frames had obvious better lateral performance; the thicker the infill wall, the higher the bearing capacity, stiffness and dissipated energy of the specimen while also the more intense the damage of the infills.

KEYWORDS: Chuan-Dou type timber frame, Wattle and daub, Seismic performance, Quasi-static

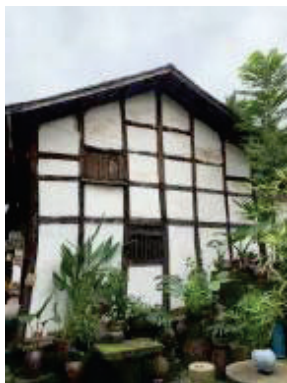
Figure 1: W&D infilled timber structure

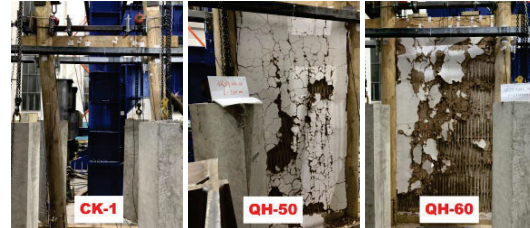
Figure 6: Test phenomenon

The embedded wall of the specimen is composed of wattle and daub and was finally finished in the form of putty smearing the surface layer. Therefore, there would be initial cracks caused by dry shrinkage cracking of the mud and specimen hoisting before the formal test. The main failure modes of the specimens are concentrated on the peeling off of the surface putty, the large area of the mud falling off, the bareness of the bamboo strips and the embedded wall separated from the frame. However, due to the variation in embedded wall and its thickness, there are differences in the stages of damage formation. The important failure process and the loading stage of each specimen are given in Table 2-4, and the crack development state and the specific failure mode are shown in Figure 6.

Loading stage	Key phenomena
150mm	The left and right column bases have unequal slip relative to the initial position
Third cycle of 180mm	The force transmission square steel pipe is partially pressed on the top surface of the wooden beam due to the loosening of the screw
First cycle of 210mm	The force transmission square steel pipe is all pressed on the top surface of the wooden beam. The steel parts rub violently against the wood
Second cycle of 210mm	The hysteresis curve does not show the load displacement path correctly and the test is terminated

Loading stage	Key phenomena
Before the test	Front surface fine cracks are distributed in the upper and lower part of the wall. Reverse surface cracks are spread all over the wall.
7.5-60mm	The new cracks continue to expand. The back putty is partially peeled. Some of the mud at the joints connected to the side of the column is stripped off.
120mm	When one side of the wall is pressed, the embedded wall is separated from the frame on the other side.
150-210mm	The shedding of mud material continues to develop. The embedded bamboo strips are partially exposed.

Loading stage	Key phenomena
Before the test	The initial cracks are long and thin, and the lifting process causes the putty to peel and fall off
90mm	Putty layer peeling keeps getting worse
120mm	Delamination of local surface mud and internal mud on the wall

Loading stage	Key phenomena
150-210mm	Cracks are developing and large pieces of clay material are falling off more and more
