LIMBERLOST PLACE: A 10-STOREY SLAB-BANDED STRUCTURE

ABSTRACT: The \$150M Limberlost Place (previously known as “The Arbour”) is a 10-storey, 16,250 m², exposed tall wood building located on George Brown College’s waterfront campus in Toronto, Canada. This project will serve as an educational hub for George Brown College, housing the Tall Wood Research Institute, a childcare centre in addition to a significant amount of teaching and social spaces for their architectural program. Fast + Epp developed an innovative large span beamless structural system that is comprised of CLT timber-concrete composite (TCC) slab bands with perpendicular CLT infill panels supported on glulam columns. This long-span flat plate system allows for flexibility in architectural programming and unobstructed mechanical distribution. An extensive testing program on the TCC slab bands was completed at the University of Northern British Columbia in 2020, which has provided valuable engineering information to the design community for future tall wood projects and composite systems. To facilitate innovation, the project received funding through the National Resources Canada Green Construction Wood Program, alongs

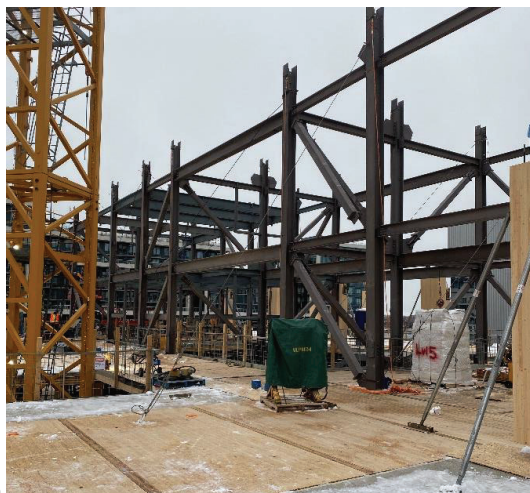
Figure 4: a) Steel braced frames, b) Steel braced frame erection sequence in 2-storey lifts.

The primary means of lateral stability consists of a long central core of concentric limited ductility steel braced frames coordinated with the stairs, elevators, and mechanical spaces in the center of the building (Figure 4). Several timber options, including CLT shear walls and glulam braced frames were explored, as was a conventional concrete core system. Ultimately, a steel braced frame system (Figure 4) was found to be the best fit for the project due to the following reasons. Firstly, the steel braces are much more slender than a glulam equivalent, allowing for greater flexibility for wall openings for architectural and required services. Secondly, the steel braced frame cores add more ductility and overstrength to the overall structure in comparison to a timber braced frame system, allowing for a more efficient seismic force-resisting system. Thirdly, the decentralized mechanical rooms require a significant number of services into the 'core' space, meaning many holes in the walls which would be practically feasible. Fourthly, the steel components can be erected simultaneously with the timber components, resulting in a faster erection period sharing the hook of one crane. The steel braces HSS, while the beams and columns within the cores are various sizes of wide-flange sections. These steel components are concealed, thus requiring no further fire protection. The design of the steel core members is governed by wind versus seismic forces in both E-W and N-S directions.

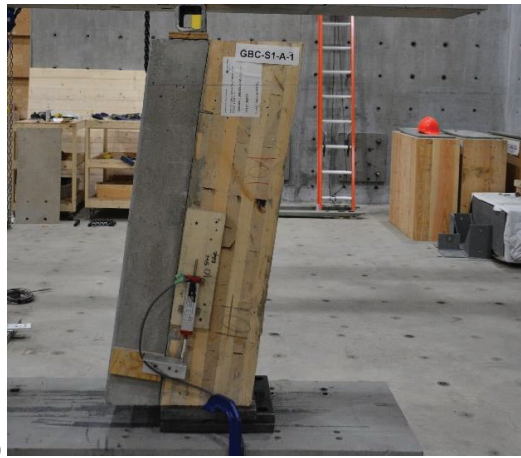
Figure 5: a-c) Specimens including steel kerf plate embedment variations, d) Small-scale test setup.

A total of 18 small-scale shear tests were conducted to investigate the capacity, stiffness, and failure mechanisms of steel kerf plates as TCC shear connectors with varying embedment depths. Steel kerf plates of 6 mm thick and 200 mm wide were installed in the CLT in a 7 mm wide saw kerf at 5° back bevel as shown in Figure 5a-c. The steel plate embedment depths into the CLT were varied: i) 35 mm deep, ii) 70 mm deep, and iii) 90 mm deep. The specimens were tested under in-plane shear by rotating 12° , similar to the procedure suggested in EN-408 [5]. The loads were applied according to EN-26891 [6] with a displacement-controlled protocol at a rate of 5 mm/min as shown in Figure 5d.

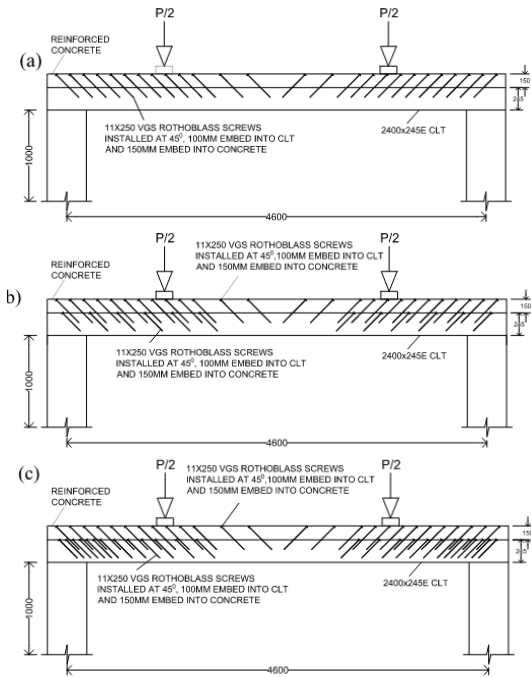
Figure 7: Test series S3: half-scale TCC with screw connectors: a) unreinforced, b) low reinforced, and c) high reinforced CLT panels.

Test series S2 is the control series, consisting of 5030 mm long raw CLT panels (no concrete topping) (Figure 6). Test series S3 to S5 (Figures 7 to 9) are TCC slab bands consisting of 5030 mm long CLT panels with 150 mm concrete topping. The three different connector layouts (Type A to C) are shown in Figure 7 to Figure 9. Two replicates from each unreinforced, low-reinforced, and high-reinforced CLT panels and TCC slab bands were provided, for a total of 6 raw CLT panels on the control side, and 18 TCC slab bands.

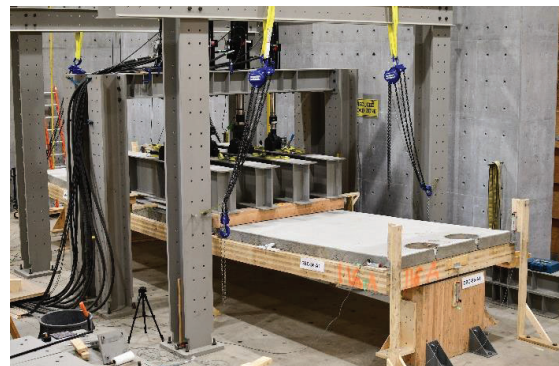
Figure 10: Schematic of 4-point bending tests.

The tests on half-scale specimens were conducted under 4-point bending as shown in Figures 10a and 10b on raw CLT panels (Series S2) and TCC slab bands (Series S3-S5), respectively. The loads were applied at one-third points using two 500 kN and two 250 kN actuators for a total maximum load of 1,500 kN, and were distributed at the third-point lines using steel spreader beams. When the specimens did not fail after reaching the 1500 kN maximum actuator load, the spreader beam was moved to mid-span to re-test the specimen under three-point loading. All specimens were tested under displacement-controlled loading at a constant rate of 15 mm/min.

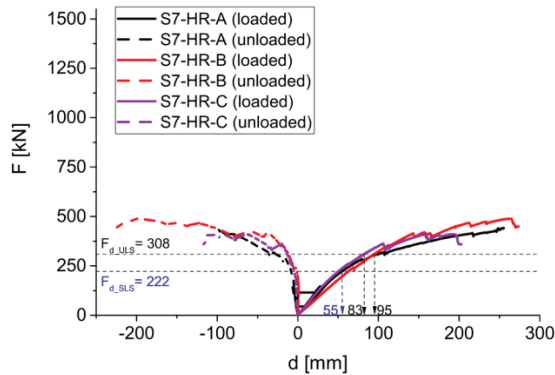
Figure 24: Load-deflection curves for series S7 - full-scale TCC bands -under torsional tests

The mid-span load-deflection curves of the full-scale TCC slab bands in series S7 under torsional loading are shown in Figure 24 and typical failure patterns are illustrated in Figure 25. The TCC slab bands with Type A screws composite connector reached first failure at 285 kN, and a maximum load of 442 kN at a deflection of 255 mm. The TCC slab bands with Type B kerf plates composite connector reached first failure at 234 kN and a maximum load of 489 kN at a deflection of 261 mm. The TCC slab bands with Type C HBV reached first failure at 257 kN, and a maximum load of only 413 kN at a deflection of 159 mm. Under torsional loading in series S7, the first failure was always triggered by the pull-out of the glued-in rod from the column support as shown in Figure 25c followed by failure in bending at mid-span on the loaded side at ultimate loads (Figure 25a). Therefore, in the final project design phase, all glued-in rods are capacity protected using 15 $\phi 16 \times 400$ mm glued-in threaded rods were used instead of 12 $\phi 16 \times 250$ mm rods used in tests, see Figure 25c.
