DEVELOPMENT OF TEMPORARY STRUCTURE USING CLT PANEL: INVENTION OF CONSTRUCTION AND VERIFICATION BY CONSTRUCTION EXPERIMENT

ABSTRACT: Temporary buildings have the advantage of being able to meet sudden demand. In recent years, the demand has been affected not only in the event of a disaster but also due to COVID-19 infection. This paper shows a temporary structure that can be used repeatedly for the purpose of constructing a temporary building using Cross Laminated Timber (CLT), and confirmed its practicality through construction experiments.

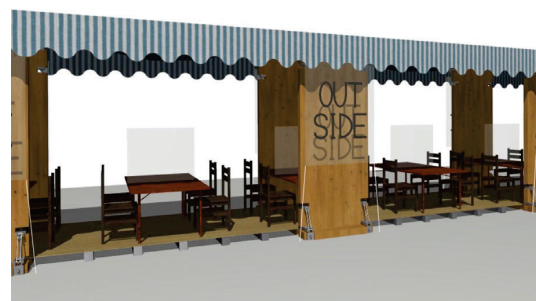
Figure 2: Image of terrace seats with the developed unit as the core

The temporary structure developed in this paper is composed of four CLT (3-layer, 3-ply, Japanese cedar) panels with the same cutting at the four corners and a steel joint with a truss mechanism. Fig. 1 shows the elevation of the temporary structural system on each side, and Fig.2 shows an image of using as restaurant on the street.

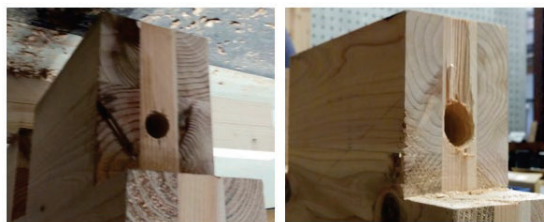
The CLT prepared in this study was not pre-cut at the factory, but was hand-processed at the site. A particular problem was the machining error in machining the 16mm through-hole for the stud bolt to pass through, which exceeded the expected error in the design stage. The cause was thought to be the storage method of the CLT before processing, and about 2 mm of warpage occurred in the long axis direction during processing. In manual drilling, it is difficult to keep vertical and horizontal, but warping made this process even more difficult. As a result, in this construction experiment, as shown in Fig. 10, the hole drilled during processing was expanded to a maximum of 21 mm and assembled. If the steel joints are assembled first, as in this case, the error absorption performance of the steel cannot be fully demonstrated, so it can be said

Figure 10: Through hole in CLT before and after modification

that it is necessary to improve it to absorb the deformation of the wood after processing, assuming reuse.

Regarding the integration of the wall material and the ceiling panels, in the previous procedure, there were two steel joints. As a result, it was confirmed that the error was concentrated in the final joint and the stud bolt could not pass through. As mentioned above contents, the expansion of the through hole of the CLT panel was made the largest in this part, and it is necessary to review the assembly error.
