FEDERATED USE OF HYGROTHERMAL MONITORING DATA IN MASS TIMBER BUILDINGS: OPPORTUNITIES AND CHALLENGES

KEYWORDS: moisture monitoring, mass timber, construction phase

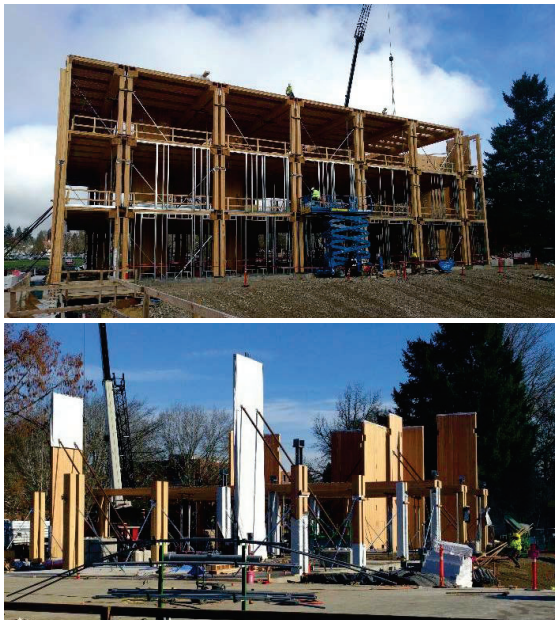
Figure 1: Zone 1 of the PFSC, Corvallis, Oregon, during construction (up), detail of temporary moisture protection during transportation and erection (bottom)

The PFSC is a three-story building completed in Corvallis, Oregon in 2019. The location has a Mediterranean/dry-summer subtropical climate with mean annual precipitation of 1295.4 mm and temperatures ranging from 2°C to 30°C over the course of the year. The building's gravity load-bearing system comprises glulam beams and columns, cross-laminated timber (CLT)-concrete composite floors, and a mass ply panel (MPP) roof. The lateral force resisting system features self-centering, post-tensioned CLT shear walls. The construction of the timber structure began in winter 2017 and was planned in three sequential spatial zones to minimize exposure to the weather. To protect against moisture during construction, a vapor permeable coating was applied in the shop to exposed end grains, such as panel edges, connections, and cut-outs, as well as to the faces of glulam members and visible CLT panels. Additionally, temporary tarps were placed on the upper edges of the CLT wall panels to prevent water from entering through any discontinuities (Figure 1).

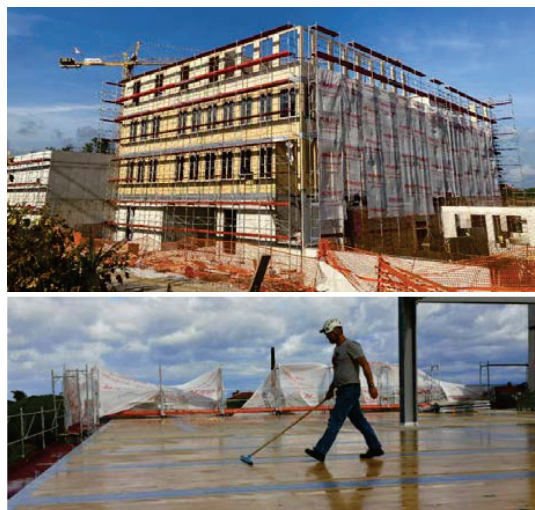
Figure 2: InnoRenew CoE's building, Izola, Slovenia, during construction (up), detail of the CLT floors (bottom)

InnoRenew CoE's building is located in a Mediterranean seaside climate in Izola, Slovenia, with 1313 mm mean annual precipitation and temperatures ranging from 1.7°C to 28.9°C over the course of the year. It is a 4-story 8194m² building with a concrete podium and three timber stories featuring CLT panels and glulam. The building was completed in February 2022. No extraordinary measures against rainwater were taken during construction, and the building was exposed to outdoor conditions until the roof was installed. CLT panels were not equipped with protection membranes. However, in-plane panel-to-panel floor connections were sealed using surface-applied tapes to avoid water penetration between the panels (Figure 2).

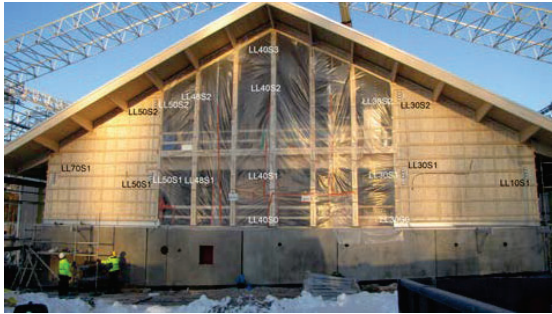
Figure 3: The main building of Hyytiälä Forestry Field Station after removal of construction shelter. Six groups of MC sensors are indicated with black text.

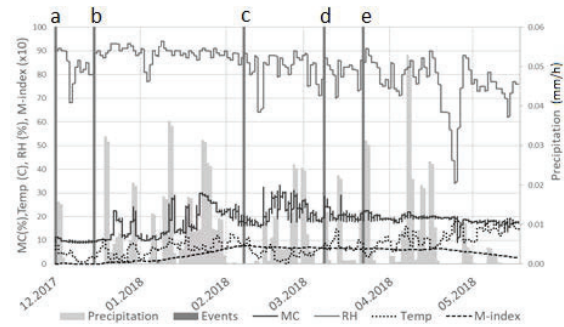
Figure 6. Corvallis. MC, RH, Temperature, precipitation data, M-index. Vertical lines: (a) installation of sensors in the shear wall; (b) installation of the 1st floor, which partially sheltered the north side of the wall; (c) completion of the roof framing and (d) weather protection, with the exclusion of the stairwell where the monitored shear wall was located; and (e) temporary construction suspension.

Vertical lines on the graphs depict certain construction key dates. Figure 6 refers to the first six months of construction of the PFSC in Corvallis. Throughout this period, the monitored location was continuously exposed to outdoor conditions. The plotted MC data correspond to measurements taken in the fourth ply of the CLT panel, from south to north, at the upper part of the tendon shaft of the shear wall. During the monitoring period, the location was subject to wetting, resulting in moisture content (MC) increases exceeding 24%. Subsequently, a slow drying process occurred, bringing the MC to around 18% after 5 months. The M-index, which was calculated using the air temperature and relative humidity (RH) data collected near the installed sensor, indicates a slight risk of mold growth.

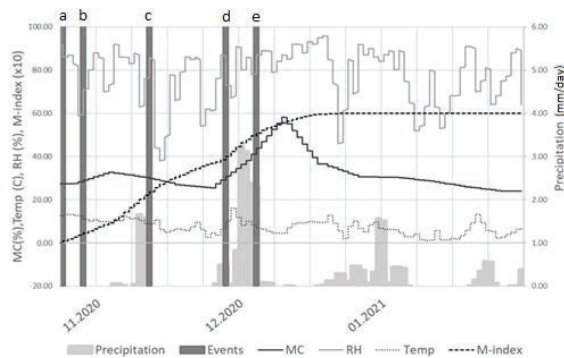
Figure 8. Izola. MC, RH (estimated), Temperature, precipitation data, M-index. Vertical lines: (a) erection of the CLT floors (b) timber structure complete, (c) window installation complete, (d-e) period of heavy rainfalls and reported leaks.

A third example, in Figure 8, shows discontinuous MC hand-held readings taken on a CLT floor panel in the building in Izola. The measurements were taken at different depths and positions close to an in-plane floor connection and the average of these readings is presented in the plot. The figure also includes climate data, key construction dates, and the calculated M-index.

As it can be observed, a spike in the MC corresponding to a period of heavy rainfall, which began in December 2020. During this time, the building's structure was complete, but the roofing assembly had not yet been finished, resulting in leaks and wetting of the floor connection details.

The plot also illustrates the increase in the M-index curve calculated from the RH values estimated using the inverse sorption equation based on the MC values [23], as no RH sensors were installed in that location at the time.
