SKYTEBANEN BRIDGE – A TIMBER TRUSS BRIDGE WITH AN INTERMEDIATE SUSPENDED CONCRETE DECK

ABSTRACT: Skytebanen bridge is a timber truss bridge built for the Norwegian Public Roads Administration in 2019. It has a single span length of 40.0 m and a width of 5.0 m with one notional traffic lane. It is constructed with two dual pitch timber frames, with a concrete deck between. The timber frames are mounted in an asymmetrical manner which gives an irregular aesthetical expression. The timber frames have a total height of 10.8 m. The bridge combines timber in its primary load carrying system with concrete deck and steel floor beams. In this paper some aspects of special interest from the design perspective are highlighted.

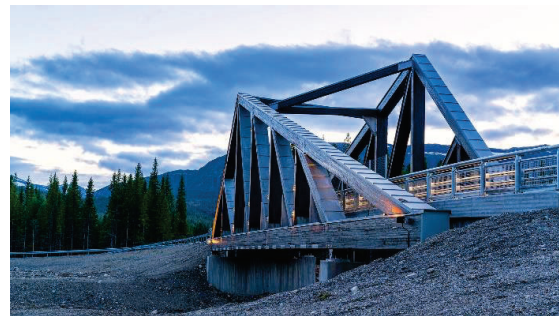
Figure 2: The bridge seen from the east side. Photo: Jan Inge Larsen

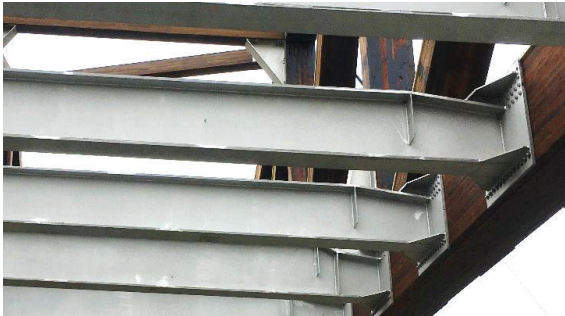
The connection between floor beams and the lower chord was designed with laterally loaded lag screws. Since the load is applied eccentrically it was also installed bolts in the bottom of the beam to reduce the action of torsional moments on the lower chord. Since the distance between the lag screw group and the lower bolts were quite big, the lower bolts were placed in vertically oversized holes to enable the wood to expand and contract due to moisture content, as outlined in Ch. 3.1.1.

Figure 12: Floor beams connected to lower chord. Photo: Viggo Jakobsen, Consto Nord AS

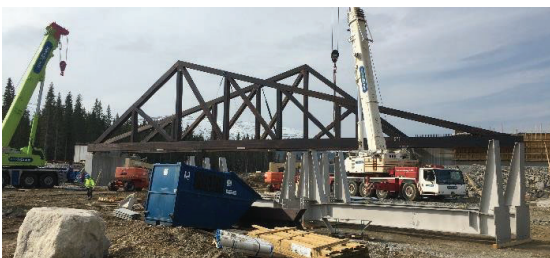
The bridge was built for the NPRA, by Consto Nord AS. Glulam and steel constructions were delivered by Moelven Limtre AS. The bridge parts were produced in factory and the trusses assembled on site, before each truss and the transverse beams were erected by crane. The concrete deck was casted in-situ after erection of the trusses.

Figure 13: Trusses after erection. Photo: Viggo Jakobsen, Consto Nord AS
