# METHODOLOGY OF REHABILITATION OF TIMBER STRUCTURES IN HISTORIC BUILDINGS

Amorim Faria, José<sup>1</sup>

**KEYWORDS:** Design methodology; Rehabilitation of timber structures; Historic Constructions; Case study

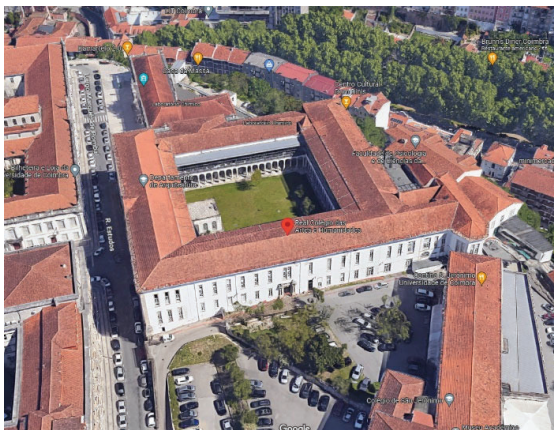
Figure 1: General view of the building

The College of Arts is part of the University of Coimbra, founded in 1290. Currently, it is used as Faculty of Architecture. The construction of the College of Arts began in 1568, see Figure 1.

The building has undergone successive changes over time in terms of volumetry and use, highlighting a major reform on the early twentieth century, with the expansion of the construction in height and the use of new materials, such as cast iron columns on the raised floor, for the installation of the University Hospital of Coimbra, operating at this site until 1986.

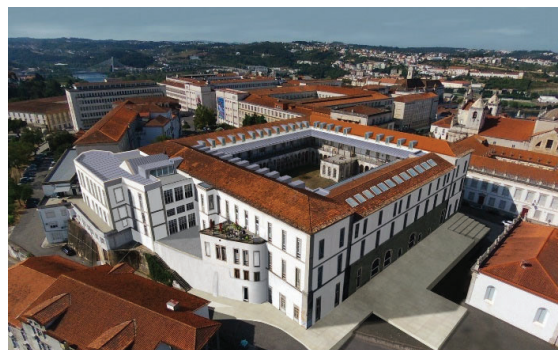
Figure 2: 3D view of the designed building at the end of the works

In addition to the rehabilitation and conservation work of the existing construction systems to be maintained, the Architecture project provides for the demolition of some additions and annexes that were carried out on the northern outskirts of the building, during the operation as a university hospital.

Figure 2 shows a 3D image of the building after completion of the works that are today still in the design phase and beginning of the demolition works.

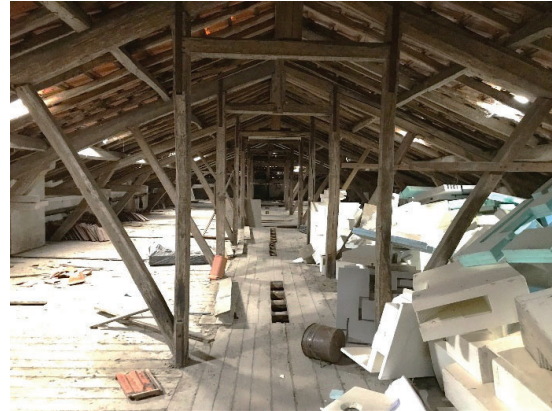
Figure 4: General view of the roof

The coatings of the roof are supported by wooden girders in solid wood, two by slope and one on the ridge, separated from each other around 1.9m to 2.3m

approximately, see **Error! Reference source not found.**

The current floor is made of solid wood and has approximately 1560m<sup>2</sup> along the east, south and west wings of the building, see Figures 4 and 7.
