TESTING OF CONNECTIONS TAKEN FROM OLD NAILED ROOF TRUSSES

Sascha Schwendner¹, Lars Völlmecke², Phien Ho³, Jens Fischer⁴, Werner Seim⁵

ABSTRACT: Experimental testing of nailed connections taken from old roof trusses is presented in this paper. To enable the further use and preservation of nailed roof trusses, it is important to understand how the nail corrosion and aging processes of steel and wood affect the load-bearing capacity and deformation behaviour of such structures. The hypothesis was investigated whether corroded nails allow an increase in load-bearing capacity. Several old and new joints were tested in a first test series, and the results were very promising regarding the initial assumption. However, more tests must be carried out to verify the results.

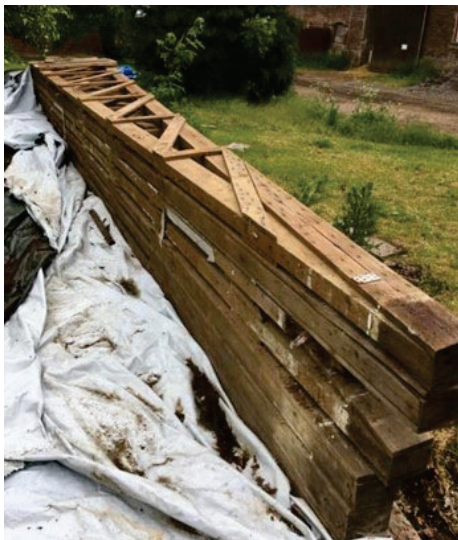
Figure 2: Roof trusses

outside under a tarp sheathing for several years (see Figure 2). This structure has been exposed over time to different climatic conditions, which have caused significant corrosion at the joints and local cracks to appear in the timber. On the other hand, some nodes are completely undamaged, so, there was a wide range between intact and considerably damaged nodes.

In order to be able to investigate the behaviour of aged nodes, trusses were chosen from a structure which had been used primarily for roofing a car wash and later a beverage store. After demolition, the trusses were stored

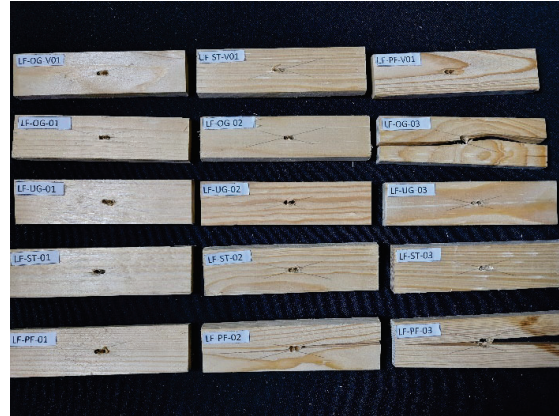
Figure 15: Embedment strength: specimens after the test

The test specimens for the embedment strength test are shown in Figure 15. As specified in the standard, all tests were performed perpendicular to the grain. The characteristic value of the embedment strength is almost identical for the chord and the strut, but the strut shows a significantly higher scattering. Results are summarised in Table 2.

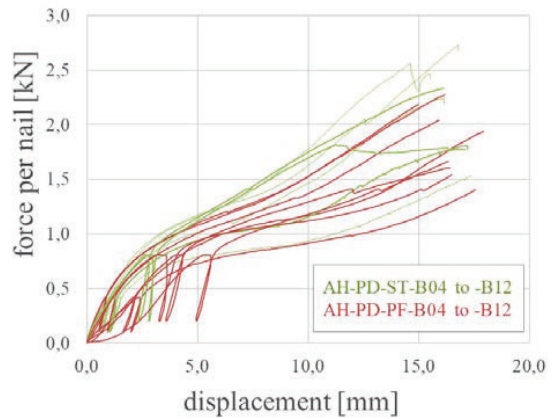
Figure 16: Load-displacement curve – comparison between old strut and post

The connection of the struts could generally take a higher load per nail than the connection of the posts. This was most probably due to the larger contact area and the greater friction associated with it. Additionally, the spacing and the edge-distance of the fasteners were larger compared to the posts. Typical load-displacement curves of connections of struts and posts are depicted in Figure 16.
