Seismic Performance Evaluation of a Traditional Wooden Townhouse that did not Collapse in the 2016 Kumamoto Earthquake

ABSTRACT: This study presented the results of the structural investigation of a *machiya*, a traditional Japanese wooden townhouse, located in Kumamoto City, which is not significantly damaged during the 2016 Kumamoto earthquake. The seismic performance of the house was evaluated using the limit strength calculations. In addition, the effect of through columns, which were present various parts of the house, was considered using a simplified model. Time history response analyses were conducted using the observed ground motion records, and the differences in the maximum response story drift due to the presence or absence of through columns were investigated. The following findings were obtained. 1) The main house had no full mud walls in the ridge direction on the first story, and most of the columns were through columns. 2) The base shear coefficients for the main house were 0.02 in the ridge direction for a story drift of 1/60 rad. The horizontal resistance was considerably small. However, the house did not collapse during the 2016 Kumamoto earthquake. 3) Time his

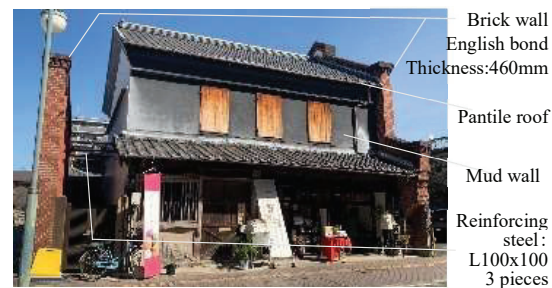
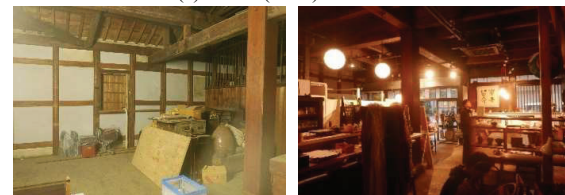
Figure 1: Exterior and interior views (taken on 10/18/2019)

Figure 1 shows the exterior and interior of the target house. The target house was built around 1915–1917.

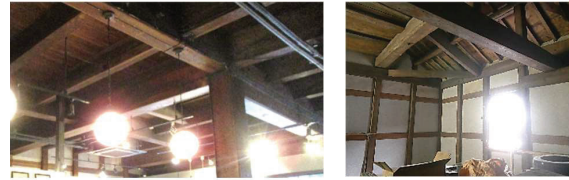
Figure 3: Structure of each part (taken on the day of the structural investigation)

The structure of each part is shown in Figure 3, and the framework and floor plan of the house are shown in Figures 4 and 5, respectively.

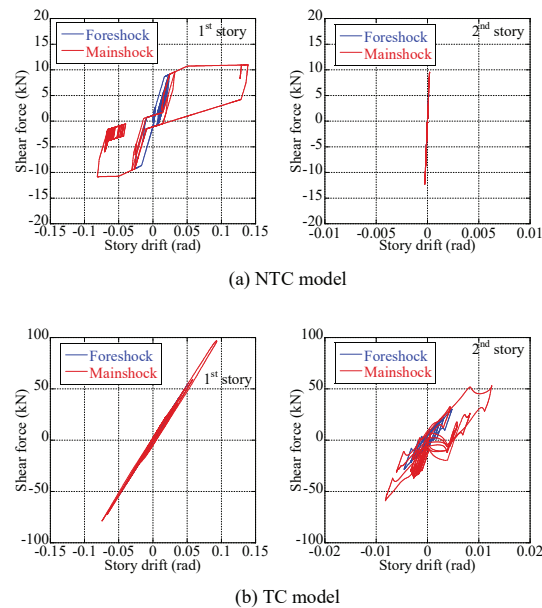
Figure 13: Relationship between the inter-story shear force and the story drift (input: Oe continuity)

In this study, the relationship between the inter-story shear force and the story drift for each floor obtained from the analysis is shown in Figure 13 using the example of continuous input of observed earthquake waves in Oe. The results of the NTC model are shown in (a) and (b) while those of the TC model are shown in (c) and (d). Furthermore, the time history changes of the story drift for the first story are shown in Figure 14.

In the TC model, the second story deforms elastically within its range, while only the first story undergoes significant deformation. In comparison to the NTC model, the maximum response story drift of the first story in the TC model decreases by approximately 36% from 1/7 rad to 1/11 rad. Furthermore, for the second story, the ratio of the maximum response story drift to that of the first story is approximately 0.2% in the NTC model, but it increases to approximately 14% in the TC model, and the second story undergoes plastic deformation in the TC model. These results confirm the effectiveness of through columns in equalizing the story drifts of each story. It is apparent that residual deformation from the foreshock remains in the NTC model based on the observation of the time history response of the story drift of the first story, while it is not observed in the TC model. These tendencies were also observed with the Kasuga seismic input.

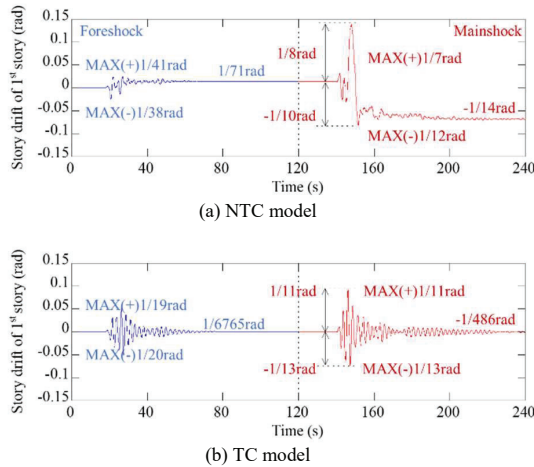
Figure 14: Time history changes of story drift for the first story (input: Oe continuity)
