## OBSERVATIONS OF SMOULDERING FIRE IN A LARGE TIMBER COMPARTMENT

Harry Mitchell<sup>1</sup>, Rikesh Amin<sup>1</sup>, Panagiotis Kotsovinos<sup>2</sup>, Mohammad Heidari<sup>3</sup>, Daniel Thomson<sup>2</sup>, David Barber<sup>4</sup>, and Guillermo Rein<sup>1</sup>

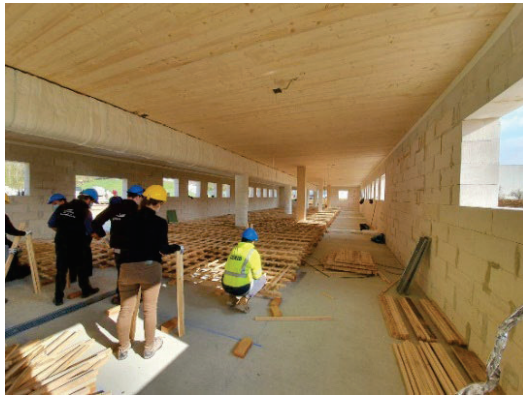
The CodeRed experiment series comprised of a 352m<sup>2</sup> compartment with a CLT ceiling and two glulam columns [12], as shown in figure 1. In the three experiments discussed (CodeRed #01 [5], #02 [6], and #04 [7]), the ventilation (50% reduction in CodeRed #02) and level of encapsulation (50% CLT encapsulated in CodeRed #04) were varied to investigate their impact on fire dynamics and charring during and after the end of flames.

**Figure 1:** Photo of CodeRed compartment before ignition.
