FUNDAMENTAL STUDY ON REPAIR BY EPOXY RESIN MIXED WITH CELLULOSE FIBER TO RECOVER BENDING PERFORMANCE OF WOODEN PARTS

ABSTRACT: This study conducts basic research on the reinforcement effect achieved by mixing epoxy resin and cellulose fiber to gauge the bending performance. Flowability tests indicated that increasing the amount of cellulose fiber relative to epoxy resin decreases flowability, and resins containing approximately 5% cellulose fiber are easier to apply. The compression test results indicated that the compressive strength of the material decreased upon mixing epoxy resin with cellulose fiber. However, the test piece containing cellulose fiber showed higher compressive strength than Cedar and Douglas fir. Compression test results confirmed that when the wood was filled with epoxy, the reinforcing effect achieved was greater than that of sound wood; it was sufficiently effective as a compression repair material. Furthermore, bending test results showed repair work utilising epoxy resin helped recover the bending performance of the test pieces with a 35% defect. Thus, the composite resin of cellulose fiber and epoxy resin is effective as a repair material for the bending

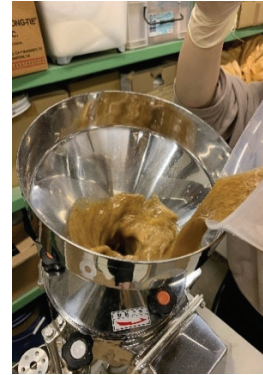
Photo 1: Separation work

- (1) After adding distilled water into the rice straw and letting it stand, the process of pulverizing the rice straw with a mass collider is repeated to remove lignin and hemicellulose from the cellulose surface in the cell wall. This exposes the cellulose to the surface. The material input is shown in **Photo 1**.

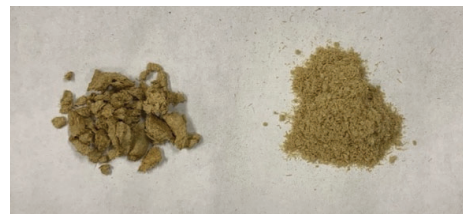
Photo 3: Cellulose fiber after drying

- (3) Dry in a drying oven (60 °C). The cellulose condenses and hardens when the cellulose fiber is dried. They are broken up after drying to finish the process. **Photo 3** shows how it looks after drying.

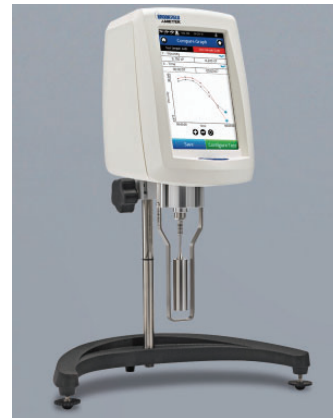
Photo 5: B-type viscometer [13]

Viscosity measurements were performed using a B-type viscometer. The B-type viscometer is shown in *Photo 5*. To measure the viscosity, a sample liquid was placed in a container such as a beaker and the spindle was immersed in the liquid. When the motor was rotated, the spring and spindle also rotated; however, the spring is twisted by the flow resistance of the measured sample. This twist is detected by a torque sensor and obtained as a torque value. The viscosity is calculated from the constant determined by the combination of this torque value and the spindle speed.
