USING X-RAY COMPUTED TOMOGRAPHY TO MEASURE FIRE DEGRADATION OF A TIMBER CONNECTION

ABSTRACT: The charring behaviour of timber elements under fire is well understood, however, the effects of fire and heat on connections are not equally well known. Timber connections often use steel fasteners, like screws or angle brackets, which conduct heat much better than wood. Moreover, these fasteners lose their mechanical resistance and capacity under elevated temperatures. X-ray computed tomography (CT) can be used to reconstruct the internal structure of wood non-destructively. It should therefore be possible to use this technology to also study the progressive degradation due to fire of a timber connection. The goal of the present study is to investigate how CT can be used to analyse the degradation of a timber connection due to fire. Samples of Norway spruce with self-tapping screws were scanned before and after a fire exposure, and mechanical tests were performed. The results indicate that the degradation due to fire in a timber connection can be observed in CT scans, but that certain measures need to be taken to minimise the effects of image artefacts due to X-ray scattering and photon

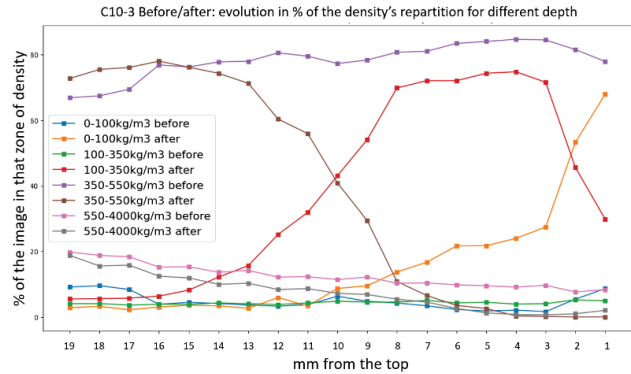
Figure 10: Evolution of density zones on the top 20 mm of the sample, before and after fire exposure

Figure 10 shows this evolution for one representative sample before and after fire exposure along the top 20 mm from the surface exposed to fire. The figure clearly shows a shifting of the density from zone 3 (350-550 kg/m³) to zones 1 and 2 (0-350 kg/m³) when approaching the exposed surface. For the same sample before the fire exposition, we can notice that the zone classification remains constant when traversing the sample. Note also the rise of zone 1 (0-100 kg/m³) close to the top of the sample, which was due crack opening during the burning.

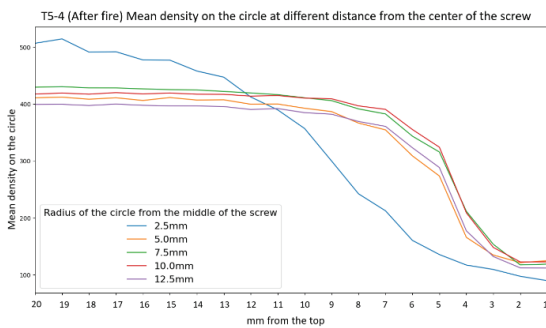
Figure 17: Graph of density measured on circles around the screw hole for samples after 10 minutes fire exposure and where the screw axis was parallel to the fibre direction

Figure 17 **Erreur ! Source du renvoi introuvable.** shows the evolution of the degradation around the screw hole on a representative sample after a fire exposure of 10 minutes and where the screw axis was parallel to the fibre direction.

In contrast to the perpendicular case, the average density of the innermost circle clearly drops below the density of the areas further away from the hole when approaching the top (burnt) surface, which happens at around 10 mm from the top. This indicates that heat degradation in the screw hole has occurred. The lower density in the hole can also be observed in the corresponding scan in Figure 18.
