# FIRE SAFETY OF MID-RISE BUILDINGS WITH LIGHT TIMBER STRUCTURES – STUDIES OF THE FIRE RESISTANCE OF A NOVEL CONSTRUCTION SYSTEM

**ABSTRACT:** A novel construction system with light timber structures is being developed for mid-rise timber buildings. Requirements for the fire resistance of the building elements and structures increase with taller buildings because the consequences of a fire are higher than for small buildings. Mid-rise buildings therefore need fire resistance of 60-90 minutes. Floor elements with light timber structures have been studied with regards to the fire performance. Experimental results for the floor construction designed for large spans are presented here. The experimental results show that it is possible to achieve fire resistance REI 90 or more for the floor. The results indicate that large void cavities in the construction delays the charring of the timber structure. The construction provides fire protection of the main beams throughout the full fire scenario.

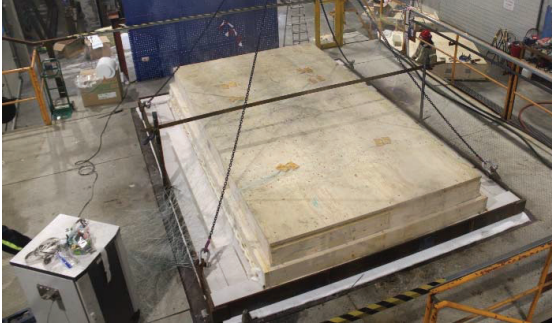
**Figure 1:** The floor specimen mounted on the horizontal furnace (Photo: RISE Fire Research AS)

The standard test method described in EN 1365-2 [4] was used. The floor specimen is placed on top of a horizontal furnace with dimensions 3080 mm x 4060 mm, see Figure 1. Siporex elements are used to cover the furnace completely, as the specimen is not wide enough, see pt. 2.2. A few deviations from the test method were made; on the cold side of the floor only the thermocouples for measurements of the average temperature change were installed, external load was not applied on the floor during the test because the span across the furnace is too short to

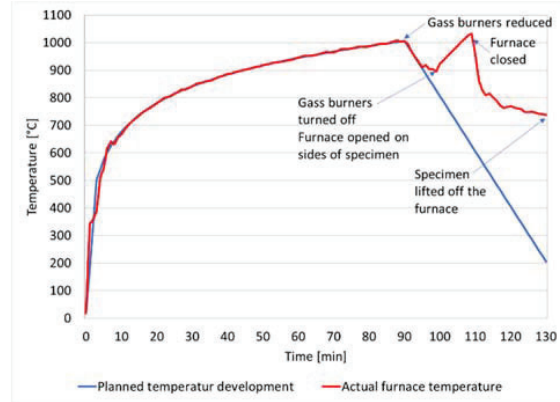
The furnace temperature followed the standard temperature-time curve given in EN 1991-1-2 [7] for 90 minutes. After 90 minutes the temperature was planned to decrease, with a cooling rate of 20°C/minute to represent the cooling phase of a complete fire, see the blue curve in Figure 6. Cooling was planned to be achieved by reducing, and eventually turning off, the gas burners, and removing the Siporex elements on the sides of the specimen.

**Figure 6:** Planned (blue) and achieved (red) temperature-time development in the furnace

The planned temperature development in the furnace was difficult to achieve, and the cooling phase became different than planned, see Figure 6. The gas burners were reduced after 90 minutes to decrease the temperature, and turned off after 100 minutes when the cooling no longer followed the planned curve. At the same time, the Siporex elements on the sides of the specimen were removed. However, cooling at the planned rate was still not possible, mainly due to the free surfaces of flanges and other combustible material. After 130 minutes, the floor was therefore lifted off the furnace for continued cooling, but without external extinguishment, see Figure 7. The presence of combustible materials such as the flanges

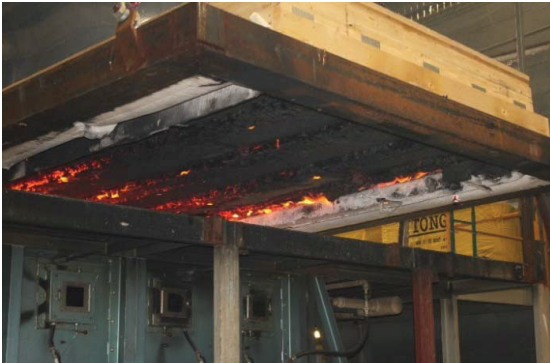
**Figure 7:** Lifting the floor off the furnace to achieve cooling

made it difficult to decrease the temperature in the furnace after the gypsum board fall-off, and removing the Siporex increased the supply of Oxygen. These are the main reasons the planned cooling was not achieved.

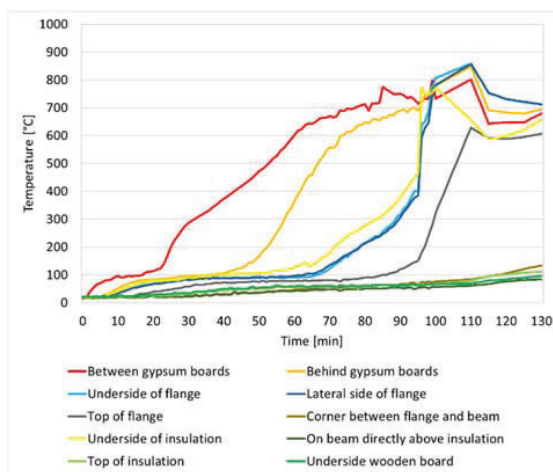
**Figure 8:** Temperature development through the floor at different positions, average of the three measuring locations in the floor

Temperatures between all layers and on the surfaces were measured with thermocouples, as described in pt. 2.3. Figure 8 shows the average of the temperature development at each position, based on three measuring points. Observed fall-off of the gypsum boards and measurements of start of charring of the flanges are given in Table 1. The charring temperature of wood is defined to be 300°C in EN 1995-1-2 [8]. Time to start of charring is therefore determined by the time at which the temperature on the surface of the wood reaches 300°C.

Figure 8 shows a considerable difference between the temperature behind the gypsum boards and on the undersides and lateral sides of the flanges. The temperature on the unexposed surface of the gypsum boards increased fast after evaporation of the moisture in the boards, while on the other surfaces the heating rate was considerable slower. At its maximum the difference is approximately 370°C. This is probably caused by the large void cavity, which delays the temperature development considerably.

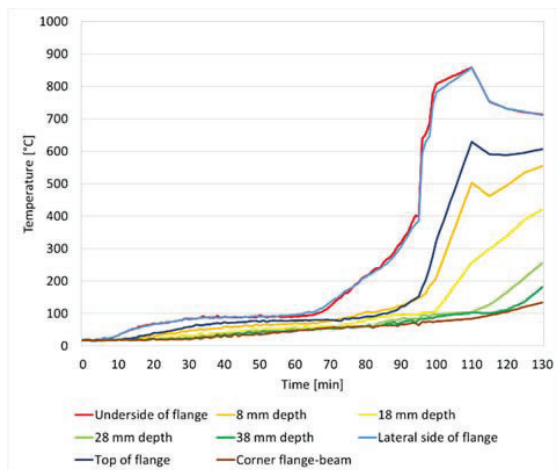
**Figure 9:** Temperature development inside the flanges at depths 8, 18, 28, 38 mm from the underside, average of the three measuring locations in the floor

The temperature development in the flanges measured by the thermocouples drilled into the wood is shown in Figure 9 for vertical direction, and in Figure 10 for horizontal direction. See Figure 5 for the positions of the thermocouples.

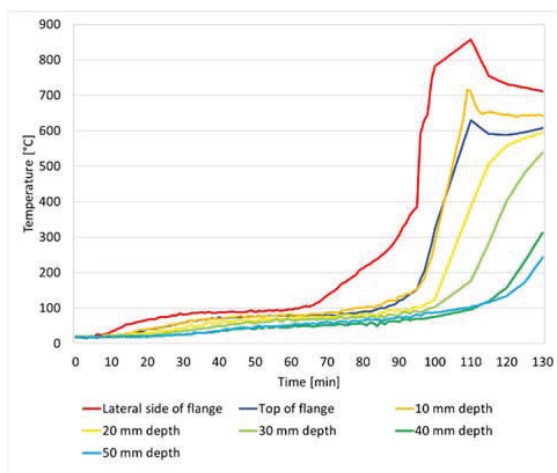
**Figure 10:** Temperature development inside the flanges at depths 10, 20, 30, 40, 50 mm from the lateral side, average of the three measuring locations in the floor

On top of the flange the temperature approximately 20 mm in from the corner, see Figure 3, follows the temperature at depth 10 mm in the flange from lateral side. This indicates that there is some air leakage between the flange and the insulation. This leakage is negligible in the corner between the flanges and beams, at distance 75 mm from the lateral side of the flanges.

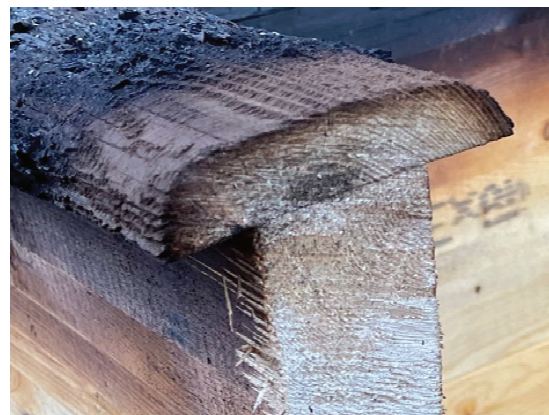
**Figure 11:** The residual cross-sections of the flanges after the fire experiment. The main load-bearing beam is discoloured but not charred

The residual cross-sections of the flanges were also measured physically after the fire experiment at three positions, see Figure 11 and Table 2. These are not at the same positions as the thermocouples. Residual height and width, plus width of the "shelf" of the flange for insulation to rest on, are similar to the last readings before the thermocouples were disconnected after 130 minutes, see Table 2. The cooling phase continued after this for approximately 125 minutes, but the charring of the timber stopped early in the cooling phase or the charring rate decreased considerably.
