TIMBER CLADDING DISCOLOURATION IN TROPICAL MONSOON CLIMATES

ABSTRACT: This paper addresses the factors affecting timber facade discolouration in tropical monsoon climates. We measure the colour change of timber cladding in the northern (N), eastern (E), southern (S) and western (W) orientations in relation to the prevailing wind directions through a year-long field test. The objective is to find a way to guide the timber cladding discolouration in a more controlled manner. The background aim of this research is to reduce the existing negative preconception of timber resulting from the visual discomfort of uneven timber colour change, which contrasts with the established industrial aesthetic norms. The following tectonic configurations were tested: i. Red balau (*Shorea collina*) timber cladding in horizontal and vertical orientations and ii. Norway spruce (*Picea abies*) and red jabon (*Anthocephalus macrophyllus*) cross-laminated timber walls overlaid with ultraviolet-filtered glazing. The discolouration was measured using a Konica Minolta handheld spectrophotometer CM-2600d, and the results were assessed in the colour space of CIE $L^* a^* b^*$. The average discolouration (ΔE^*)

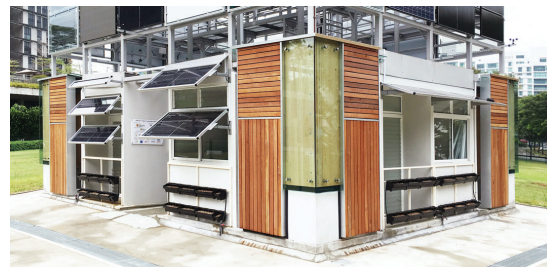
Figure 1: Tropical MET architectonics study set up at NUS-CDL T² Lab (Nov. 2018)

The National University of Singapore (NUS) and City Developments Limited's (CDL) Tropical Technology (T²) lab (Figure 1) was set up at the end of 2018 at NUS in Singapore to investigate the influence of aspects of tropical climates, such as sun, wind and humidity, on photovoltaic panels, green façades and natural ventilation and the behaviour of MET under tropical climate conditions. The MET façade field test was conducted for one year, from January to December 2019, at the T² lab, which was naturally ventilated with no casting shadows from the surroundings throughout the testing period.

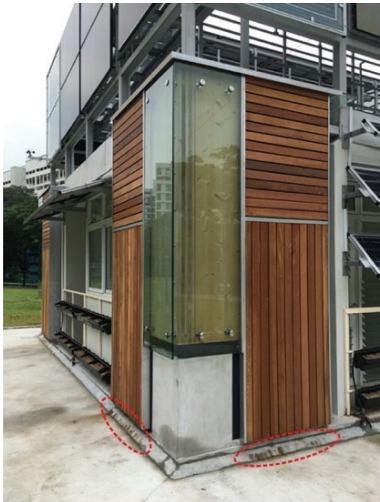
Figure 5: Brown stains on the concrete foundation were observed during the first few months after the installation. They were likely deposited by leached extractives from the red balau timber (red dotted circle, October 2018)

The installation of timber cladding specimens was completed in October 2018. Temporary brown stains on the concrete foundation were observed for the first few months, which were likely deposited by leached extractives from the red balau façade. Those stains were later washed away by natural rainfall.

For the first two months between October and December 2018, the rapid discolouration (ΔE^*) between the averages of the two control samples and the 200 specimens was recorded ($\Delta E^* = 6.5\text{--}8.7$, Figure 5, 7). There were noticeable natural colour differences among

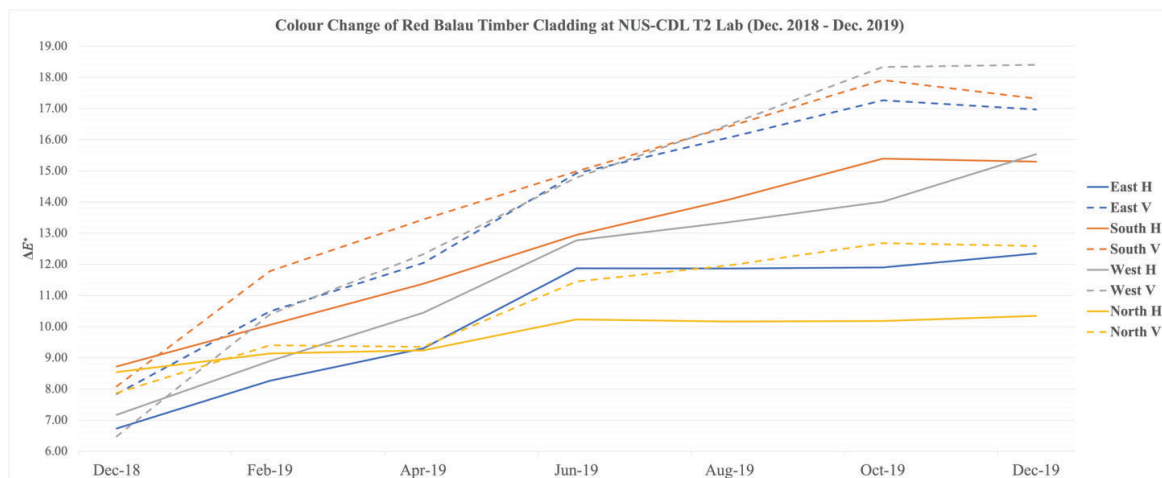
Figure 7: Discolouration of the red balau V- and H-aligned cladding in NWSE orientations.

The average colour coordinate of the two controlled samples was recorded as ($L^*: 48.24$, $a^*: 11.58$, $b^*: 19.50$) prior to the testing. The colour measurement of the 200 specimens in the NWSE orientations was recorded at two-month intervals between December 2018 and December 2019 for one year. The colour change field test result is shown in Figure 7.

It is generally observed that the overall colour change (ΔE^*) on the S and W sides increased faster than on the E and N sides, except for the E-side V-aligned boards, where the ΔE^* increased as fast as the S and W sides. The colour change (ΔE^*) differences in orientations generally grew wider over the testing period (Figure 7).

According to the annual wind rose for 1981–2010 in Singapore [12], the two prevailing wind directions are NNE and S. However, the Figure 7 discolouration analysis indicated that the highest discolouration occurred in the S and W orientations, while the N orientation recorded the lowest level of discolouration.

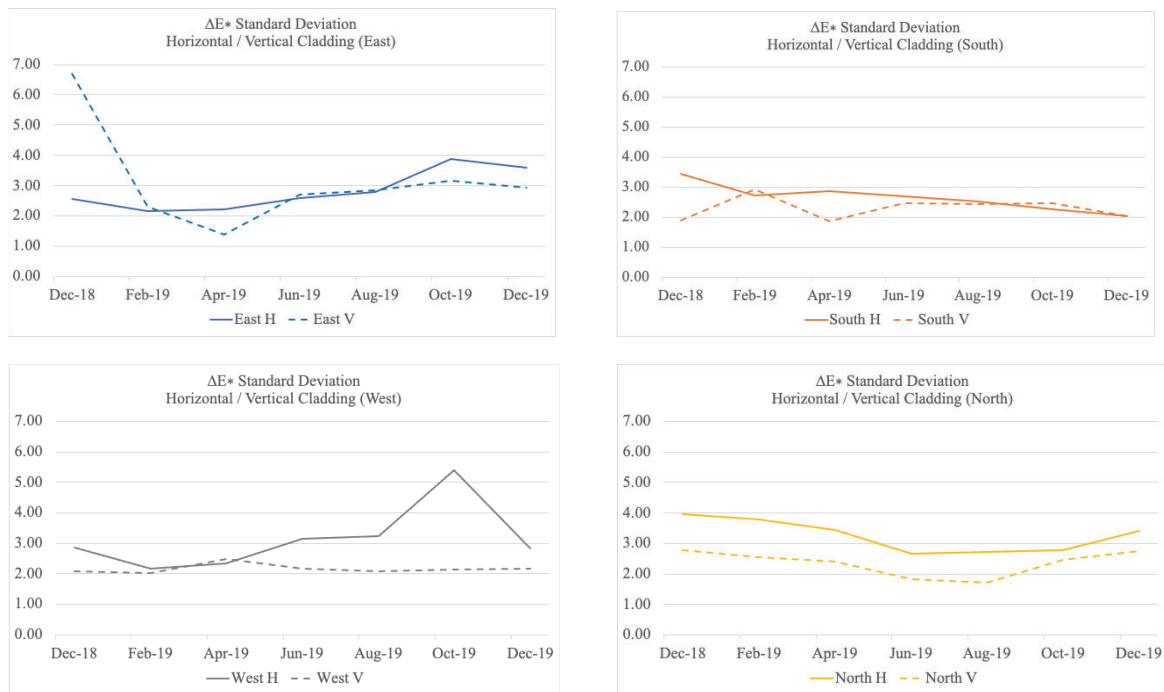
Figure 8: ΔE^* standard deviation among all H-aligned and V-aligned boards in each orientation (Upper Left: E, Upper Right: S, Lower Left: W, Lower Right: N.)

The ΔE^* standard deviation among all H- and V-aligned boards in each orientation was computed to understand the degree of even discolouration. While it was generally observed that the discolouration (ΔE^*) standard deviation became smaller in the S orientation, there were two exceptions: the E-side V-aligned boards at the beginning of the testing period and the W-side H-aligned boards in October 2019.

The latter helps us to understand the cause of the late ΔE^* standard deviation spike in the H-aligned boards, which fluctuated more than the V-aligned boards throughout the testing period. As UV-degraded lignin is washed away by rainwater, the fluctuated discolouration (ΔE^*) standard deviation might be caused by water-flow patterns over the H- and V-aligned boards.

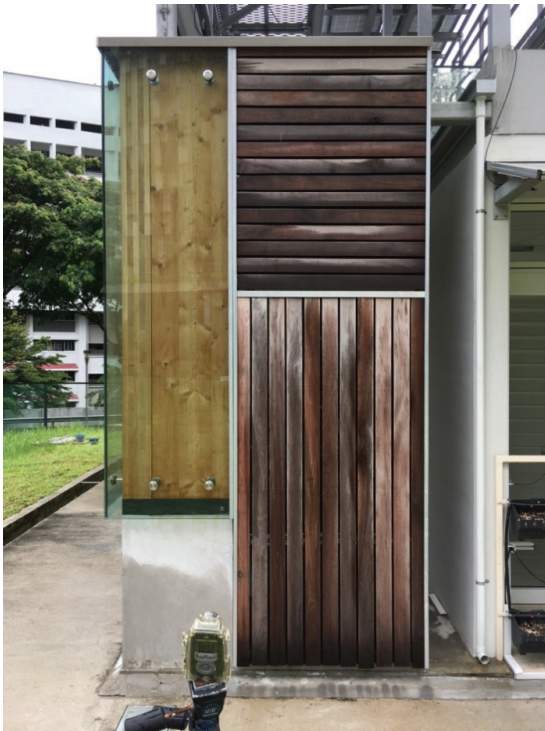
Figure 9: An example of cladding at the SW corner (facing S) a few hours after heavy monsoon driving rain (Nov. 2019). The H-aligned cladding was mostly still wet, while the V-aligned cladding dehydrated relatively quickly.

Figure 9 illustrates an example of the S facade a few hours after the heavy monsoon driving rain. While the H-aligned boards retained their wet surfaces for a longer period, the V-aligned boards exhibited a relatively quicker drying process, which implies that the driving rain ran smoothly along the direction of the wood grains. In contrast, the water flow direction was not aligned with the direction of the wood grains in the H-aligned boards, resulting in wet surfaces for relatively prolonged periods.

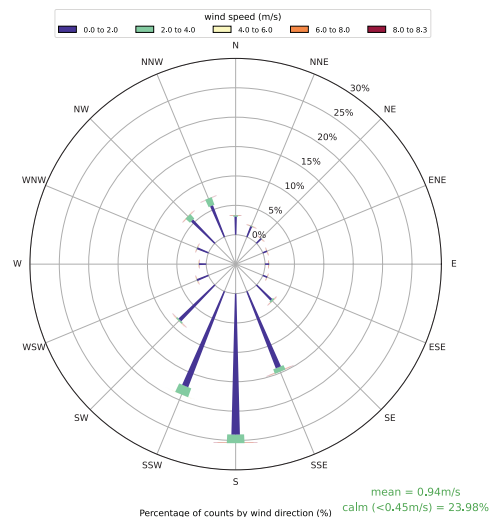
Figure 10: Annual wind rose based on the measurement at the NUS-CDL T² lab, January to December 2019

We further analysed the wind data recorded at the rooftop level of the NUS-CDL T² lab. The 2019 annual wind rose at the T² lab (Figure 10) indicates the clear S and SSW dominant wind directions, which deviate from the prevailing monsoon wind direction. Therefore, the higher and faster discolouration in the S and W orientations might be a result of heavy monsoon driving rain by the locally dominant S and SSW wind at the T² lab site.

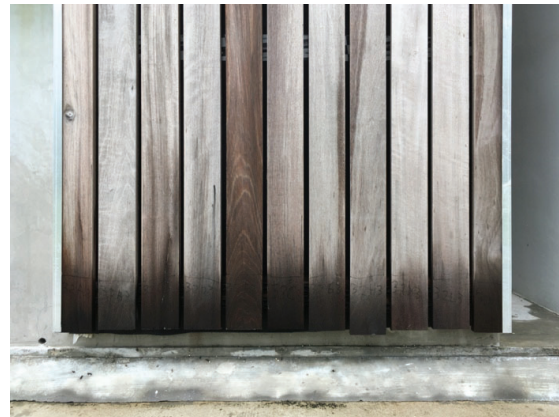
Figure 11: An example of a wet timber cladding base several hours after heavy monsoon driving rainfall (November 2019) – generally, the bottom of the S and W façades became wet and grew darker because of the splash water up to 400 mm above ground level.

Figure 11 illustrates an example of timber cladding on the S side several hours after heavy monsoon driving rainfall. Generally, we observed that the wall base became wet and darker up to 40 cm in height in the S and W orientations. The tendency was less obvious in the N and E façades. If we were not mitigating the splash water through additional technical measures, it would probably have been better to raise the bottom end of the timber cladding at least 40 cm from the ground level to protect the timber façade from constant wetting, especially for the façade facing prevailing wind directions in the tropical monsoon climate.

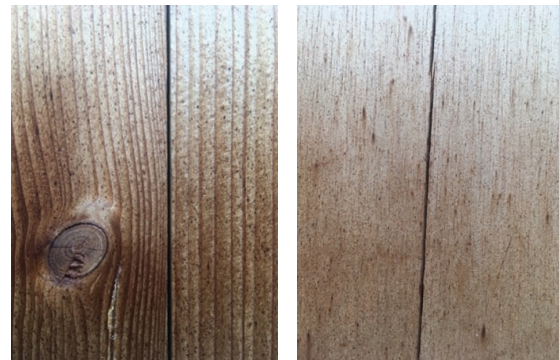
Figure 12: Examples of colour changes after 28 months exposure behind UV-filtered glazing (April 2021). **Left:** Norway spruce (*Picea abies*), **Right:** Red jabor (*Anthocephalus macrophyllus*).

As the UV-filtered glazing effectively protected the CLT walls from monsoon driving rain, there were no signs of grey colour weathering observed for both the Norway spruce and red jabor. However, noticeable colour changes were still observed, especially for the Norway spruce, which changed to a darker reddish colour over time, while the red jabor's change in colour was less obvious. There were also noticeable cracks on both the Norway spruce and red jabor CLT walls (Figure 12). The visually noticeable dark reddish colour changes of the Norway spruce and the moderate reddish colour of

the red jabor seemed to be a part of the ageing process, which is considered as a slow thermal oxidation [3]. It is generally observed that heat can directly alter the colour by causing hydrolysis and the oxidation of wood components. As timber dries, extractives accumulate on the surface, where they oxidise to a brown colour. The effect is usually short-lived, as rainwater will remove the extractives, although it can persist where the timber is protected [15]. It is also generally accepted that colour changes increase as the temperature increases. Long-term exposure to heated double facade cavities in hot and humid climates probably accelerates the ageing process. This phenomenon requires further investigation.

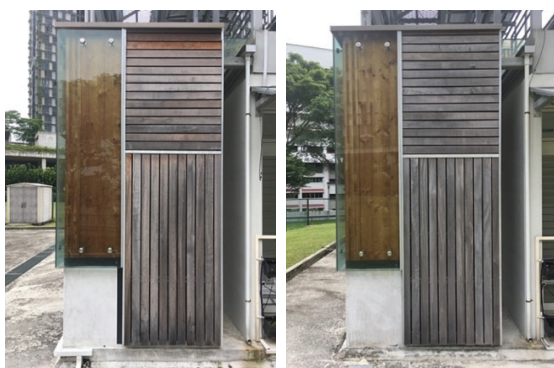
Figure 13 Examples of overall timber cladding discolouration after 28 months exposure (April 2021). **Left:** N side, **Right:** S side. The S-side facade exhibits mostly darker colours, while the N-side facade exhibits more moderate and uneven colour changes.

The general observation was made that the H-aligned boards exhibited lower overall discolouration (ΔE^*) than the V-aligned boards. The ΔE^* standard deviation for the H-aligned boards was generally higher than the V-aligned boards throughout the testing period. After a 28-month period, the V-aligned boards exhibited a relatively homogeneous facade outlook, while the H-aligned boards still exhibited uneven weathering (Figure 13).
