DEVELOPMENT OF SIMPLE REPAIRING HARDWARE FOR DAMAGED ENDS OF WOODEN BEARING WALLS

ABSTRACT: This study investigated the repairing effect for wooden bearing walls (which wall length was 910 or 1820mm) which are repaired by developed hardware. The study found that the repair was effective in increasing the maximum load and energy by more than 100% and 120%, respectively, but not very effective in increasing stiffness, which was often less than half. Additionally, the structural performance of the load-bearing walls with only the repair hardware was found to be equivalent to that with only the joint hardware, suggesting that these performances contribute to the overall structural performance of the repaired specimens.

KEYWORDS: Bearing wall, Repairing hardware for brace-ends, Structural performance

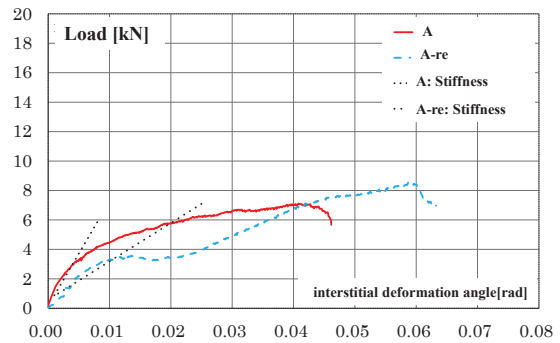
Figure 14: Comparison with A and A-re(Load-angle)

The load-deformation angle relationships of the specimens with the joint hardware and after repair are then shown in Fig. 14-17.

The study found that the initial stiffness of the specimens after repair tends to be smaller than before repair. This is likely due to the slightly smaller stiffness of the wall with only the repair hardware. However, the maximum load and displacement at maximum load of the specimens after repair were clearly larger than before repair. This suggests that the repair is effective in increasing the load-bearing capacity and deformation performance of the wall.

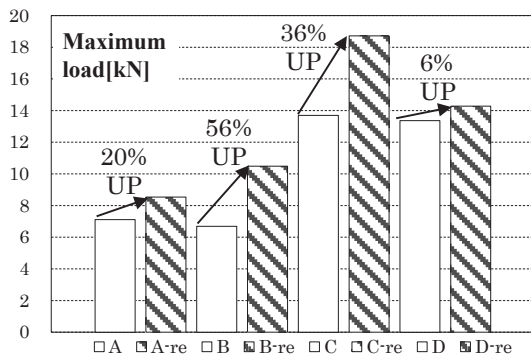
Figure 20: Comparison of maximum loads on specimens before and after reinforcement

Comparisons before and after repair are shown in *Table 4*, maximum load comparisons in *Fig. 20* and energy comparisons in *Fig. 21*.

The study found that compared to the specimens before repair, the specimens after repair had lower initial stiffness, but increased maximum load and energy. The ratio of the post-repaired value divided by the pre-repaired value for maximum load was 120% for the A-re specimens, 156% for the B-re, 136% for the C-re and 106% for the D-re. The energy ratios were 131% for the A-re specimens, 240% for the B-re, 173% for the C-re and 123% for the D-re. No trend was found within the scope of this study with respect to these repair effects for different wall lengths.

The study found that the use of repair hardware tends to increase the maximum load by more than 100% and the energy by more than 120%. Based on these results, it can be considered that repair hardware has a repair effect. However, it has been shown that the maximum load of those using only repair hardware is 85% of those using only joint hardware. It is believed that the joint hardware after damage also contributes to some extent, working in a combined manner and resulting in a higher maximum load. With regard to energy, the contribution of the repair hardware is considered to have been significant. In terms of stiffness, on the other hand, the results showed that there was no significant repair effect.
