## THE PRESENT STATE AND ISSUES ON RETROFITTING OF HISTORIC TIMBER-FRAMED BRICK CONSTRUCTION BUILDINGS IN JAPAN

**ABSTRACT:** In the late 19<sup>th</sup> century, the method of timber-framed brick construction (TFBC, “mokkotsu-rengazo” in Japanese) was introduced to Japan as a western technique. After a while, it became apparent that the TFBC method was vulnerable to earthquakes, and hence, it was not used anymore. However, some TFBC buildings remain in Japan, and several of them require reinforcement. To ensure appropriate and smooth repairs, this paper summarizes the history, past retrofitting works, and current situation and issues regarding the restorations of TFBC buildings in Japan through document survey and building investigations.

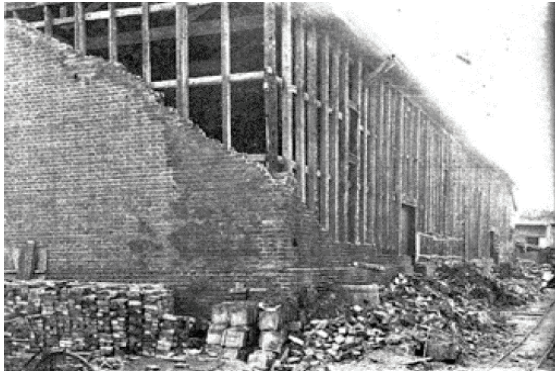
Figure 3: Damage to TFBC building during Tokyo-Yokohama Earthquake (1923) [3]

In 1923, the Tokyo-Yokohama earthquake (Kanto Earthquake) devastated masonry buildings (Figure 3). The following year, the Urban Building Law (Shigaichi kenchikubutsu hou [市街地建築物法]) (1919) became stricter, which made it difficult to construct masonry buildings in Japan. The use of TFBC was rapidly decreased. This strict standard was implemented into the current the Building Standard Law (Kenchiku kijun hou [建築基準法]) enacted in 1950.

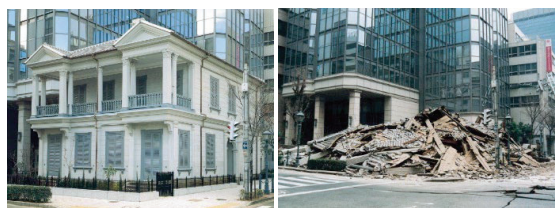
Figure 4: The Jugobankan Building before (left) and after (right) the Kobe Earthquake (1995) [4]

Timber frames and brick walls are not structurally joined together; therefore, their vibration characteristics are different during earthquakes. Consequently, there is a high risk of failure in the out-of-plane direction. In 1995, the Kobe earthquake destroyed the Jugobankan Building in the Former Kobe Foreign Concession (Figure 4).

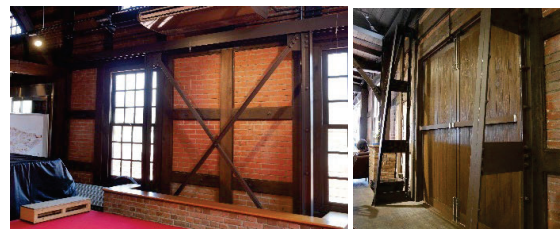
Figure 7: Reinforcements of the Former Kabuto Beer Factory (left: steel frame and brace, right: steel buttresses)

This building is located in Handa City in the southern part of Aichi Prefecture. It is registered as a national tangible cultural property and was restored in 2014. Steel braces and buttresses were installed to increase the horizontal load-carrying capacity, and pillar legs and beams were reinforced with metal fittings.

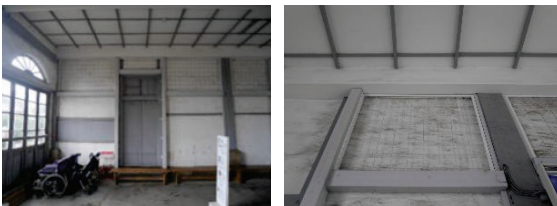
**Figure 10:** Reinforcements at the East Cocoon Warehouse (left: zoom out view, right: zoom in view), (Date of shooting: July 4, 2022)

This building is a counterpart to the West Cocoon Warehouse, and is also a national treasure and a UNESCO World Heritage Site. Although not yet fully reinforced, transitional reinforcement work was conducted between 2011 and 2012 to reduce the out-of-plane damage from earthquakes. The work includes the following: filling the gaps between the top of the brick wall and wooden girder with mortar, setting up wire meshes, and reinforcing columns and beams on the brick walls facing a busy passageway [6].

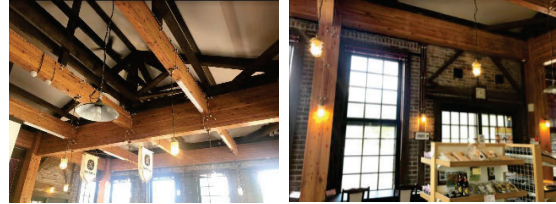
**Figure 11:** Reinforcements at the Former Engine Room of Kosaka Mine Manufacturing Division: interior view (Date of shooting: Sep. 10, 2019)

a coffee shop. During relocation, a new reinforced concrete foundation was cast, and reinforcing columns and beams made of laminated wood were added to the interior of the building.
