EXPERIMENTAL AND NUMERICAL ANALYSIS OF CLT FLOOR SUBASSEMBLIES UNDER CATENARY ACTION

ABSTRACT: Behaviour under combined axial tension and out-of-plane bending, typically observed in catenary action after loss of a support, was investigated on Cross Laminated Timber (CLT) floors. Uni-axial tension tests as well as combined tension and bending tests on CLT component and floor subassembly levels with screw butt joints and varying boundary conditions were performed. Bending moment capacity was shown to decrease with increasing of horizontal tension on the connection. Combined loading failure envelope was developed to observe a correlation between the test results of different scale, showing the potential of using component tests as predictors of the behaviour of more complex subassemblies.

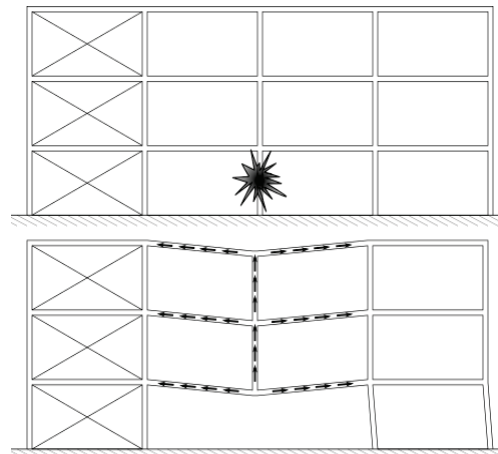
Figure 1: Catenary action after compressive element loss

One of the primary load resistance mechanisms after the loss of a load-bearing member is catenary action, which allows for redistribution of load in the structure [7] as visualised in Figure 1. It is also the main load redistribution mechanism allowed for in Eurocode 1 [4], which provides formulas for horizontal and vertical tie forces required for catenary to form. Under catenary action, the floors are subjected to combined bending and tension and therefore understanding of the effect of such combined loading on mass timber connections is instrumental for effective modelling and performance-based design. To date some early experimental work has

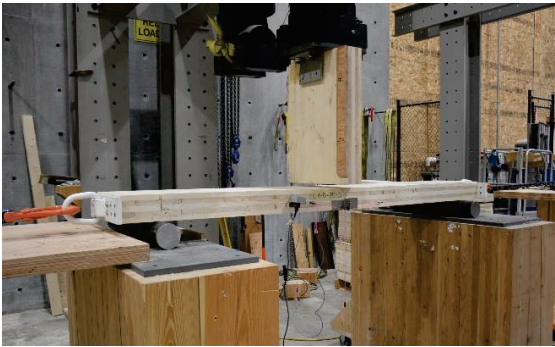
The component tests (Figure 6) were performed on the same test set-up as the full-span tests (Figure 7), but with the wall supports moved inwards to create the desired shorter span. The aim of the component tests was to gather information on the influence of tension level on the moment rotation behaviour and ultimate limit state values; therefore, the test series were designed in even increments of tension utilisation from 0%-75% (Table 2). These utilisation ratios were based on the average ultimate strength obtained from the axial tension tests. Together with the axial tension tests this allows for investigating of the changes in mechanical bending properties depending on the tensile utilisation ratio.

Figure 6: Component test experimental setup

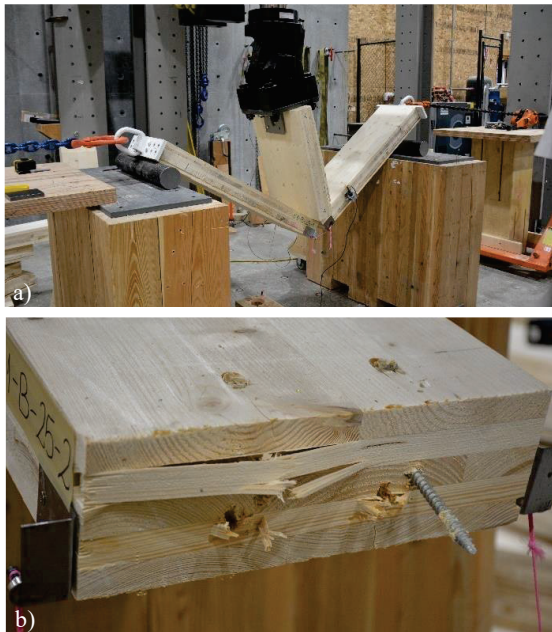
Failure of the screws in the component tests was observed in two different modes. Screws failed in withdrawal, with some having punched through the material from the headed side of the screw (Figure 11b). In either scenario material in the traverse layers of the panels was pulled due to the tension perpendicular to the grain. Some of that failure was shown to split all the way to the edge of the sample, indicating that a higher edge spacing and therefore more material to distribute the localised stresses could have a positive impact on the overall strength of that connection.

Figure 11: Butt joint component tested to maximum stroke (a) and to failure (b)

specimen from each series is plotted to illustrate the main variabilities. The maximum vertical force resistance as well as maximum rotation initially increase between series C1-B-0 and C1-B-25, with one of the latter samples not failing fully after reaching the maximum actuator stroke (Figure 11a). This demonstrates activation of the catenary action. The benefit of the tensile force to the overall strength in comparison to the bending only series is also clearly visible in the C1-B-50, however with a relatively lower deformation capacity from C-B-25. The last test series with 75% tension utilisation ratio had vertical force resistance comparable to the bending only samples, but with a much higher variability.

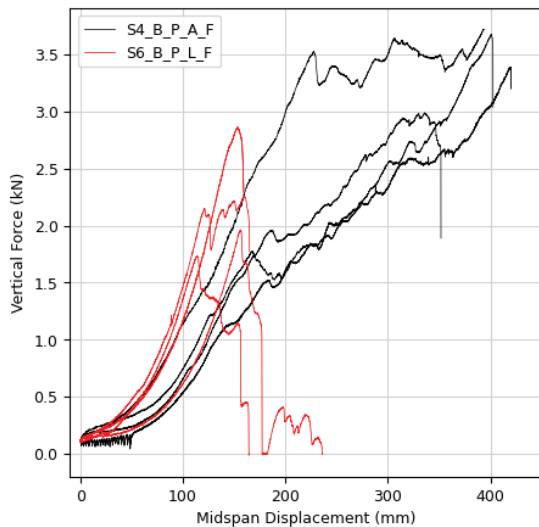
The shape of the load displacement curve is strongly influenced by the way in which the axial tension is applied, which confirms that the catenary action is the primary load resistance mechanism. For instance, in the test series where tension was increasing along with pushdown through fixed horizontal displacement (S4 and S6), the support stiffness of the system increased

throughout the test (Figure 12). The maximum tension values at supports for these test series are shown in **Error! Not a valid bookmark self-reference.** The presence of angle brackets connecting the wall stub to the floor panels did not have a great influence on the maximum tension capacity; however, it did allow for a greater deformation which positively affects the overall force capacity presented in Figure 12.

Figure 12: Fixed displacement tests force displacement curves

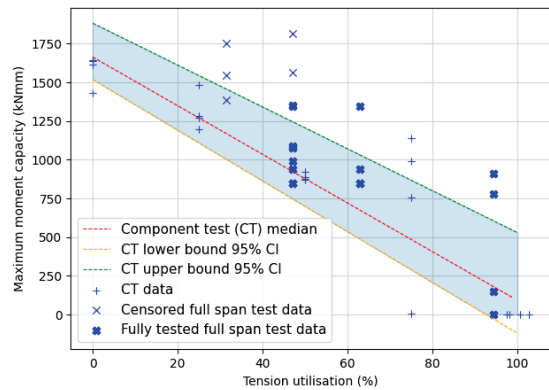
Results of the pin-support tests under constant tension have been summarised as a failure envelope for combined tension and bending in Figure 16. Each datapoint represents the maximum moment experienced by the sample and the corresponding tension utilisation value based on the axial load tests. An extreme value distribution analysis was performed on the results from 4 specimen in each of the component test series and linear regression lines were fitted through the corresponding median values and the upper and lower bounds of the 95% confidence interval.

Figure 16: Combined loading failure envelope

The moment capacity of both component and full span tests drops proportionally to the increased tensile utilisation. Horizontal withdrawal of the screw is the governing failure mode and both increased system tension as well as bending of the connection increase the tension resultant at the screw, therefore this relationship is numerically justified. As shown in Figure 15, the total of those two resultants reaching tensile capacity of the connection is the cause of connection failure.

The values of the full-span tests when compared to the component test data fit does fall on the higher side of the data distribution. This could be due to a multitude of factors such as data errors and the active changes in the effective span due to the horizontal travel distance of steel rollers, small changes in screw spacing and proportionally large variability of timber properties. However, they do still largely follow the same trend and are deemed a good predictor of the large-scale behaviours.
